**DEPARTMENT OF TRANSPORTATION**

Contract #: 04-0120F4Cty: SF/ALA Rte: 80 PM: 13.2/13.9File #: 1.28**WELDING INSPECTION REPORT****Resident Engineer:** Casey, William**Address:** 333 Burma Road**City:** Oakland, CA 94607**Report No:** WIR-029326**Date Inspected:** 23-Mar-2013**Project Name:** SAS Superstructure**OSM Arrival Time:** 700**Prime Contractor:** American Bridge/Fluor Enterprises, a JV**OSM Departure Time:** 1530**Contractor:** American Bridge/Fluor Enterprises, a JV**Location:** Job Site**CWI Name:** See below.**CWI Present:** Yes No**Inspected CWI report:** Yes No N/A**Rod Oven in Use:** Yes No N/A**Electrode to specification:** Yes No N/A**Weld Procedures Followed:** Yes No N/A**Qualified Welders:** Yes No N/A**Verified Joint Fit-up:** Yes No N/A**Approved Drawings:** Yes No N/A**Approved WPS:** Yes No N/A**Delayed / Cancelled:** Yes No N/A**Bridge No:** 34-0006**Component:** Tower**Summary of Items Observed:**

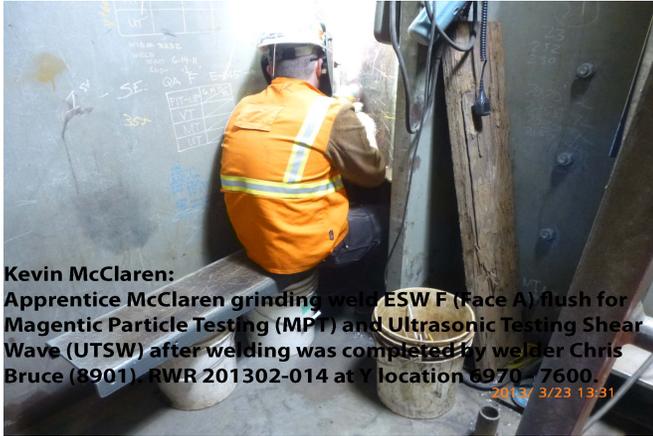
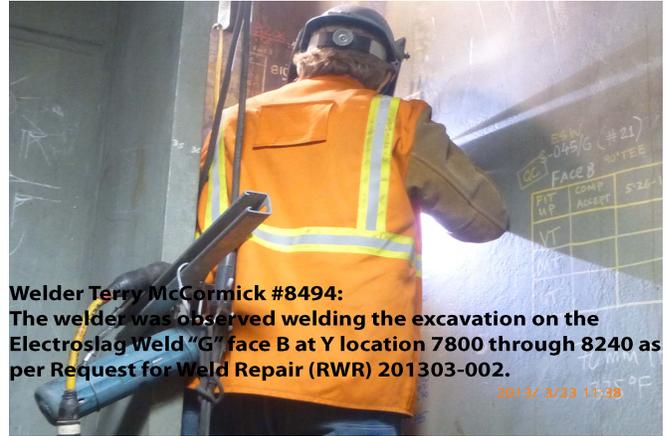
The welder was observed finishing with welding the repair excavation on the Electroslag Weld "F" at face A, at Y location 6970 through 7600 as per Request for Weld Repair (RWR) 201302-014 in way of an Ultrasonic Testing rejected indication. The indication was excavated to 630 long x 55 wide x 40 deep. The welder was observed preheating the weld to 300 degrees Fahrenheit prior to welding using the Miller ProHeat 35 with heat induction blankets. The welder utilized the Welding Procedure Specification (WPS) ABF-WPS-D15-1000-Repair Rev.3 for Shield Metal Arc Welding (SMAW). The welding parameters were verified by QC Inspector Andrew Keech throughout the day and appeared to be in compliance with the WPS noted above.

The welder was observed welding the excavation on the Electroslag Weld "G" face B at Y locations 7800 through 8240 as per Request for Weld Repair (RWR) 201303-002 in way of an Ultrasonic Testing rejected indication. The welder was observed preheating the weld to 300 degrees Fahrenheit prior to excavating using the Miller ProHeat 35 with heat induction blankets. The welder utilized the Welding Procedure Specification (WPS)
