Contract #: 04-0120F4Cty: SF/ALA Rte: 80 PM: 13.2/13.9File #: 1.28**WELDING INSPECTION REPORT****Resident Engineer:** Casey, William**Address:** 333 Burma Road**City:** Oakland, CA 94607**Report No:** WIR-029332**Date Inspected:** 16-Mar-2013**Project Name:** SAS Superstructure**OSM Arrival Time:** 700**Prime Contractor:** American Bridge/Fluor Enterprises, a JV**OSM Departure Time:** 1530**Contractor:** American Bridge/Fluor Enterprises, a JV**Location:** Job site**CWI Name:** Andrew Keech**CWI Present:** Yes No**Inspected CWI report:** Yes No N/A**Rod Oven in Use:** Yes No N/A**Electrode to specification:** Yes No N/A**Weld Procedures Followed:** Yes No N/A**Qualified Welders:** Yes No N/A**Verified Joint Fit-up:** Yes No N/A**Approved Drawings:** Yes No N/A**Approved WPS:** Yes No N/A**Delayed / Cancelled:** Yes No N/A**Bridge No:** 34-0006**Component:** Tower S-041 #09 "S"**Summary of Items Observed:**

TOWER Weld Repair Y+7030~7450

S-041 #09

Ultrasonic Testing Tower ESW

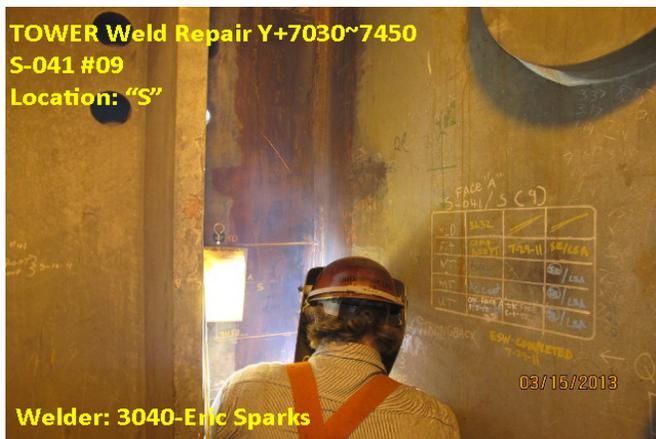
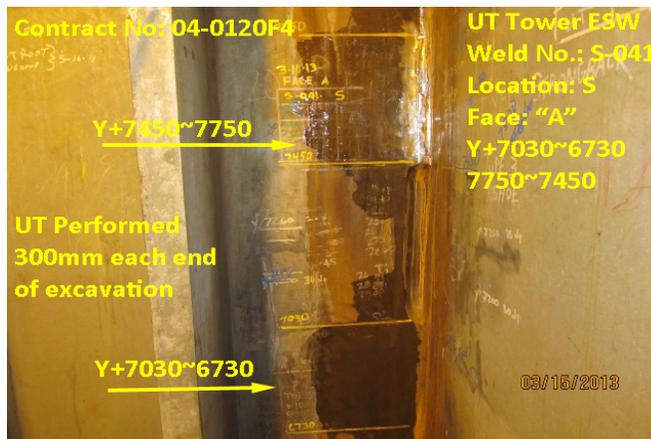
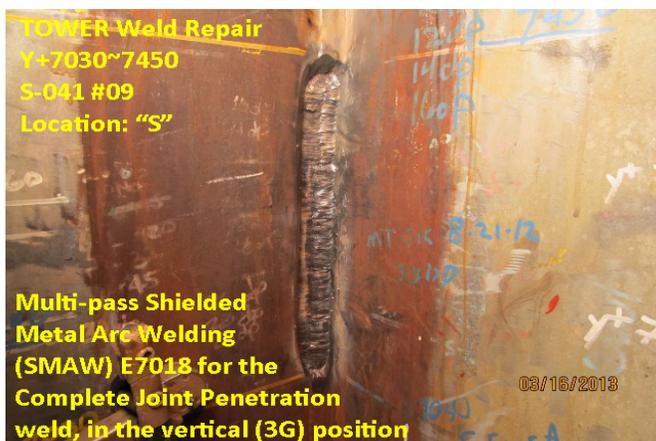
The QAI observed that welder 3040-Eric Sparks, was welding fill passes for ESW repair located between Y+7030~7450, location "S" (weld No.: S-041 #09). This QAI observed Welding Procedure Specification (WPS) ABF-WPS-D15-1000-Repair-R3 and RWR 201302-11 was utilized. The QC inspector Andrew Keech verified the excavation of the repair area as well as Magnetic Particle Testing of the excavation and found it to be acceptable, this information was relayed to the QAI. The welder performed pre-heat throughout the repair area as well as during the welding operation utilizing heat racks on the back side of the repair area at 170 degrees Celsius (338 degrees F) which was verified using a tempstik and infrared gun by the QC. The welder was using the Shielded Metal Arc Welding (SMAW) electrode E7018 for the Complete Joint Penetration (CJP) weld in the vertical (3G) position with 5/32-inch electrode for the fill passes. The welder utilized a power grinder and power wire wheel for the interpass cleaning. The QC inspector for this location was Andrew Keech and was observed verifying and documenting the welding parameters for this location, along with overseeing the welding operations. At the time METS observation was performed No issues were noted by the QAI.

The welder was grinding the starts and stops between weld layers to a bright metal. The location was still in process at the end of this QAI's shift.

This QAI performed Ultrasonic Testing (UT), in tandem with ABF QC inspector Mr. Andrew Keech, on Complete Joint Penetration Electroslag welds. Weld joint is designated as a 60mm 120-degree T-Joint, Weld No.: S-041 #9 location S. During the QA/QC tandem Ultrasonic Testing, scanning was performed 300 mm each end of the ESW excavation for longitudinal planar and transverse indications; in accordance with supplemental procedure SE-UT-D1.5-CT-108-ESW-R5. The UT inspection was performed using a 70 degree shear wave from face A; (2) transverse and (0) planar recordable indications were discovered at locations noted below. The remaining length of weld tested with indications did not appear to have a rating that qualifies as rejectable or recordable according to AWS D1.5 2002 and supplemental procedure SE-UT-D1.5-CT-108-ESW-Revision: 5.

Transverse Recordable Indications

Face A

Y+ 7750 and 7520
