Contract #: 04-0120F4Cty: SF/ALA Rte: 80 PM: 13.2/13.9File #: 1.28**WELDING INSPECTION REPORT****Resident Engineer:** Casey, William**Address:** 333 Burma Road**City:** Oakland, CA 94607**Report No:** WIR-029360**Date Inspected:** 06-Mar-2013**Project Name:** SAS Superstructure**OSM Arrival Time:** 700**Prime Contractor:** American Bridge/Fluor Enterprises, a JV**OSM Departure Time:** 1530**Contractor:** American Bridge/Fluor Enterprises, a JV**Location:** Job Site

| Bridge No: | 34-0006 | | | Component: | SAS OBG | | |

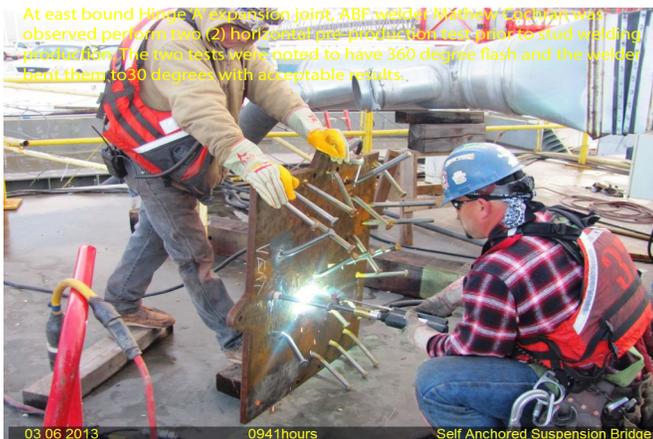
At east bound Hinge A expansion joint, ABF welder Matthew Calkins was observed perform two (2) horizontal pre-production test prior to stud welding production. The two tests were noted to have 360 degree flash and the welder bent them to 90 degrees with acceptable results.

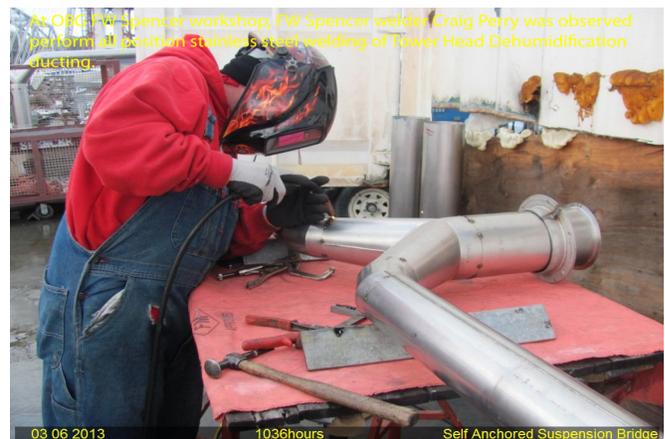
At OIG FW Spencer workshop, FW Spencer welder Craig Perry was observed perform all position stainless steel welding of Tower Head Dehumidification ducting.
