**DEPARTMENT OF TRANSPORTATION**

Contract #: 04-0120F4Cty: SF/ALA Rte: 80 PM: 13.2/13.9File #: 1.28**WELDING INSPECTION REPORT****Resident Engineer:** Casey, William**Address:** 333 Burma Road**City:** Oakland, CA 94607**Report No:** WIR-029371**Date Inspected:** 05-Apr-2013**Project Name:** SAS Superstructure**OSM Arrival Time:** 700**Prime Contractor:** American Bridge/Fluor Enterprises, a JV**OSM Departure Time:** 1730**Contractor:** American Bridge/Fluor Enterprises, a JV**Location:** Job Site**CWI Name:** See below.**CWI Present:** Yes No**Inspected CWI report:** Yes No N/A**Rod Oven in Use:** Yes No N/A**Electrode to specification:** Yes No N/A**Weld Procedures Followed:** Yes No N/A**Qualified Welders:** Yes No N/A**Verified Joint Fit-up:** Yes No N/A**Approved Drawings:** Yes No N/A**Approved WPS:** Yes No N/A**Delayed / Cancelled:** Yes No N/A**Bridge No:** 34-0006**Component:** OBG**Summary of Items Observed:**

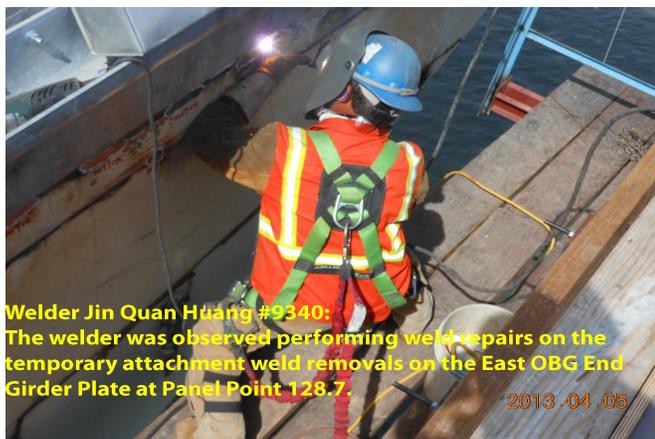
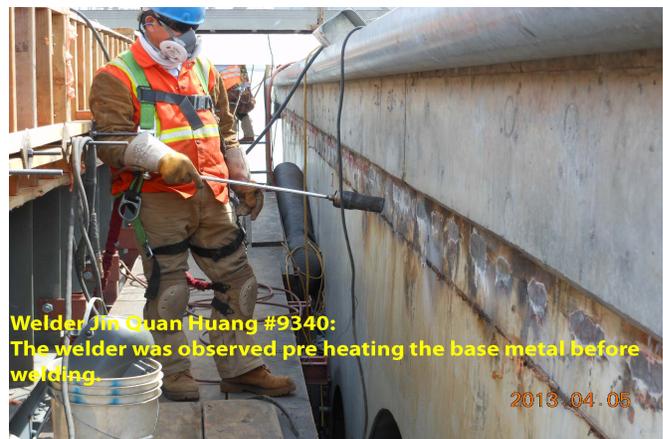
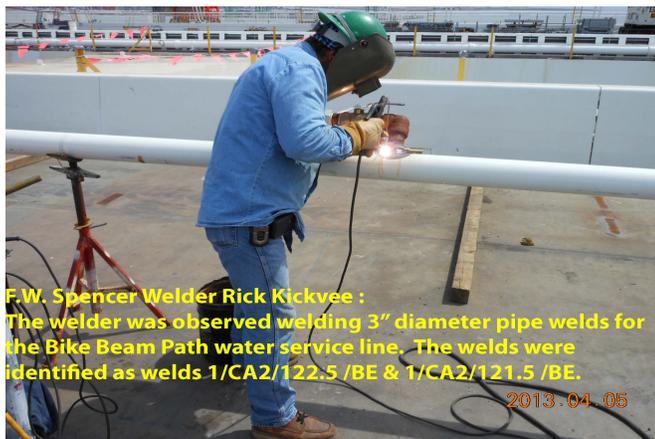
Bike Path Lifting Lugs at Panel Points 9 to 15:

- 8 locations Tested. VT and MPT Acceptable.

East OBG End Girder Plate at Panel Point 128.7:

- Base Metal Temporary Attachment removals. 80% Tested (VT & MPT Accept)
