DEPARTMENT OF TRANSPORTATION

Contract #: 04-0120F4Cty: SF/ALA Rte: 80 PM: 13.2/13.9File #: 1.28**WELDING INSPECTION REPORT****Resident Engineer:** Casey, William**Address:** 333 Burma Road**City:** Oakland, CA 94607**Report No:** WIR-029393**Date Inspected:** 08-Mar-2013**Project Name:** SAS Superstructure**OSM Arrival Time:** 700**Prime Contractor:** American Bridge/Fluor Enterprises, a JV**OSM Departure Time:** 1530**Contractor:** American Bridge/Fluor Enterprises, a JV**Location:** Job Site

WELDING INSPECTION REPORT

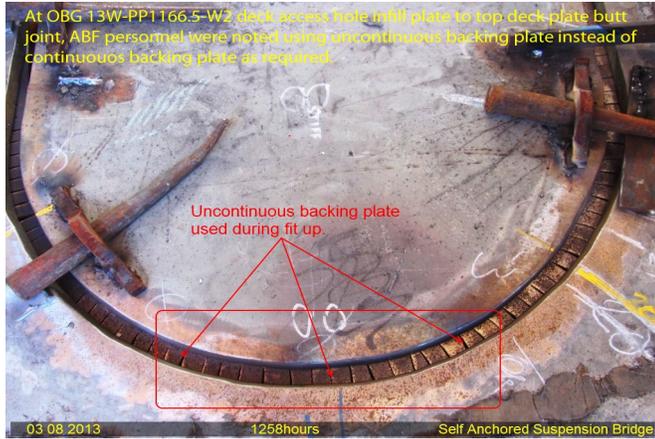
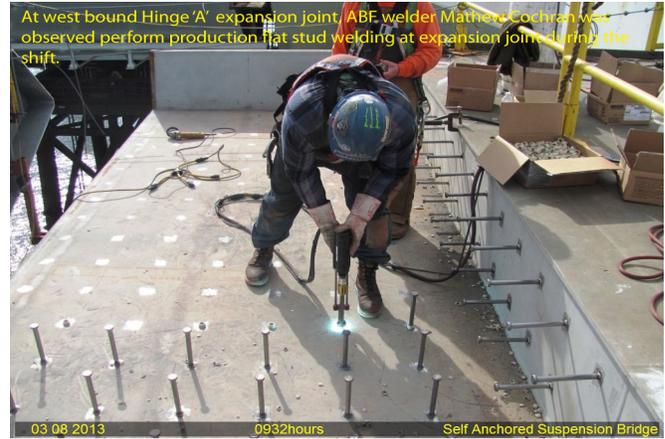
At OBG 13W-PP116.5-W2 deck access hole (DAH), ABF welder Chris Bruce was noted performing fit up on the DAH infill plate to top deck plate. The alignment was measured less than 2mm and the root opening was also measured 20mm or less which deemed acceptable to project requirements. During fit up, the backing plate that

was used was not continuous plate which is in contrary to the project requirement. Due to this infraction that was made by ABF, an Incident Report was initiated. Tack welding on the backing plate to the infill plate and top deck plate was also noted during the shift. The welder was noted using Shielded Metal Arc Welding (SMAW) with 1/8" diameter E7018H4R electrode.
