DEPARTMENT OF TRANSPORTATION

Contract #: 04-0120F4Cty: SF/ALA Rte: 80 PM: 13.2/13.9File #: 1.28**WELDING INSPECTION REPORT****Resident Engineer:** Casey, William**Address:** 333 Burma Road**City:** Oakland, CA 94607**Report No:** WIR-029419**Date Inspected:** 04-Apr-2013**Project Name:** SAS Superstructure**OSM Arrival Time:** 700**Prime Contractor:** American Bridge/Fluor Enterprises, a JV**OSM Departure Time:** 1730**Contractor:** American Bridge/Fluor Enterprises, a JV**Location:** Job Site**CWI Name:** See below.**CWI Present:** Yes No**Inspected CWI report:** Yes No N/A**Rod Oven in Use:** Yes No N/A**Electrode to specification:** Yes No N/A**Weld Procedures Followed:** Yes No N/A**Qualified Welders:** Yes No N/A**Verified Joint Fit-up:** Yes No N/A**Approved Drawings:** Yes No N/A**Approved WPS:** Yes No N/A**Delayed / Cancelled:** Yes No N/A**Bridge No:** 34-0006**Component:** OBG**Summary of Items Observed:**

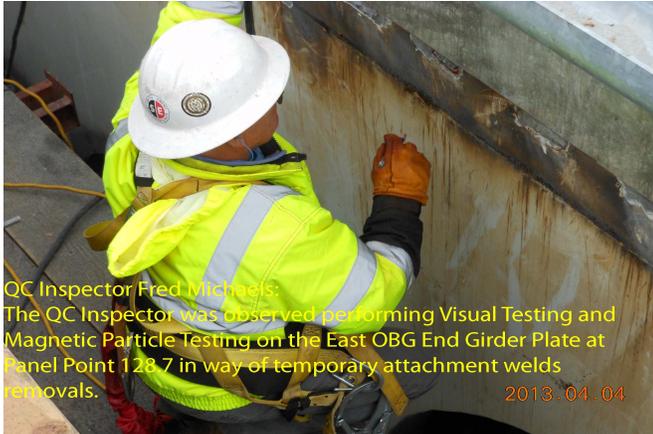
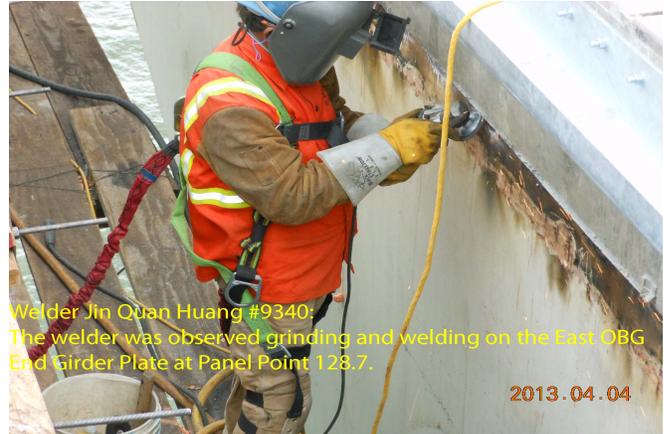
The welder was observed grinding and welding on the East OBG End Girder Plate at Panel Point 128.7. The welder was observed removing temporary attachment welds from the girder plate by grinding. After grinding the welder was noted welding areas that were visually inspected by QC Fred Michaels and found to be below the allowable depth due to grinding. The welder was observed welding utilizing the Welding Procedure Specification (WPS) ABF-WPS-D15-1004 Repair for Shield Metal Arc Welding (SMAW). The welding parameters were verified by QC Inspector Fred Michaels throughout the day and appeared to be in compliance with the WPS noted above. (As per Request for Weld Repair (RWR) 201301-019.)

- End Girder Plate at PP128.7 Temporary attachment removals. (Over 50% MPT)
