**DEPARTMENT OF TRANSPORTATION**

Contract #: 04-0120F4Cty: SF/ALA Rte: 80 PM: 13.2/13.9File #: 1.28**WELDING INSPECTION REPORT****Resident Engineer:** Casey, William**Address:** 333 Burma Road**City:** Oakland, CA 94607**Report No:** WIR-029423**Date Inspected:** 18-Apr-2013**Project Name:** SAS Superstructure**OSM Arrival Time:** 700**Prime Contractor:** American Bridge/Fluor Enterprises, a JV**OSM Departure Time:** 1730**Contractor:** American Bridge/Fluor Enterprises, a JV**Location:** Job Site**CWI Name:** See below.**CWI Present:** Yes No**Inspected CWI report:** Yes No N/A**Rod Oven in Use:** Yes No N/A**Electrode to specification:** Yes No N/A**Weld Procedures Followed:** Yes No N/A**Qualified Welders:** Yes No N/A**Verified Joint Fit-up:** Yes No N/A**Approved Drawings:** Yes No N/A**Approved WPS:** Yes No N/A**Delayed / Cancelled:** Yes No N/A**Bridge No:** 34-0006**Component:** OBG**Summary of Items Observed:**

# WELDING INSPECTION REPORT

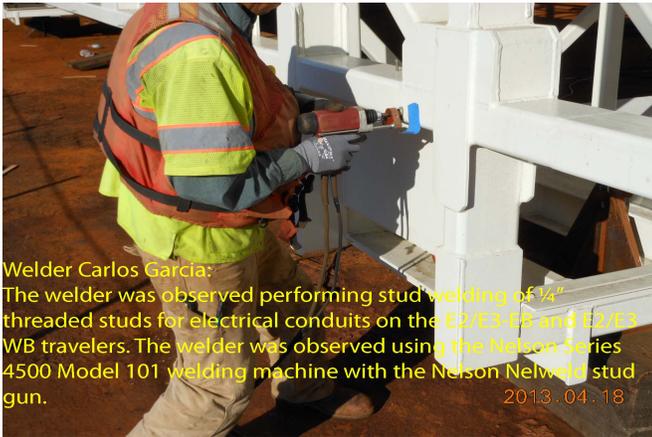
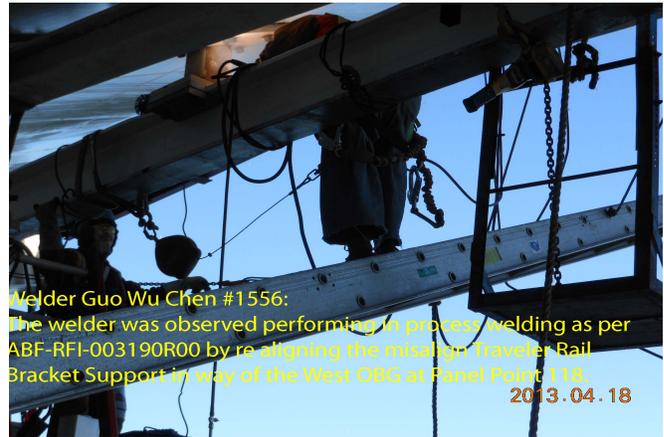
The welder was observed performing stud welding of 1/4" threaded studs for electrical conduits on the E2/E3-EB and E2/E3 WB travelers. The welder was observed using the Nelson Series 4500 Model 101 welding machine with the Nelson Nelweld stud gun. The current was set at 350 Amps with weld time at .17 seconds to produce a 0.215" weld base diameter as per Procedure Qualification Record (PQR) S003. All (100%) of the welded studs were then torque tested to 5ft-lbs as per Figure 7.3 of AWS D1.5 2002 by QC Inspector Fred Michael. Out of 39 stud welds 3 failed as witnessed by this QAI. The base metal of failed stud welds were ground flush for the rewelding of a new stud and were torque tested once they were cooled. The QC Inspector Fred Michaels was onsite monitoring the welding parameters. Welding parameters appeared to be in compliance with the PQR noted above.

The welder was observed performing in process welding on the Cover Plates seal welds at OBG 12E Panel Point 119 (-1500) in way of the K plate for the West Saddle Grillage Dehumidification Zone as per ABF-RFI-003256R00. The welder was observed pre heating the "K" plates to 300 degrees Fahrenheit prior to welding. The welding was performed utilizing the Welding Procedure Specification (WPS) ABF-WPS-D15-F1200A Rev.2 for Shield Metal Arc Welding (SMAW). The welding parameters were verified

The welder was observed performing in process welding as per ABF-RFI-003190R00 by re aligning the misalign Traveler Rail Bracket Support in way of the West OBG at Panel Point 118. The welder was observed welding utilizing the Welding Procedure Specification (WPS) ABF-WPS-D15-1060A for Shield Metal Arc Welding (SMAW). The welding parameters were verified by QC Inspector Tony Sherwood throughout the day and appeared to be in compliance with the WPS noted above.
