DEPARTMENT OF TRANSPORTATION

Contract #: 04-0120F4Cty: SF/ALA Rte: 80 PM: 13.2/13.9File #: 1.28**WELDING INSPECTION REPORT****Resident Engineer:** Casey, William**Address:** 333 Burma Road**City:** Oakland, CA 94607**Report No:** WIR-029429**Date Inspected:** 20-Apr-2013**Project Name:** SAS Superstructure**OSM Arrival Time:** 700**Prime Contractor:** American Bridge/Fluor Enterprises, a JV**OSM Departure Time:** 1530**Contractor:** American Bridge/Fluor Enterprises, a JV**Location:** Job Site**CWI Name:** As noted below**CWI Present:** Yes No**Inspected CWI report:** Yes No N/A**Rod Oven in Use:** Yes No N/A**Electrode to specification:** Yes No N/A**Weld Procedures Followed:** Yes No N/A**Qualified Welders:** Yes No N/A**Verified Joint Fit-up:** Yes No N/A**Approved Drawings:** Yes No N/A**Approved WPS:** Yes No N/A**Delayed / Cancelled:** Yes No N/A**Bridge No:** 34-0006**Component:** SAS Tower**Summary of Items Observed:**

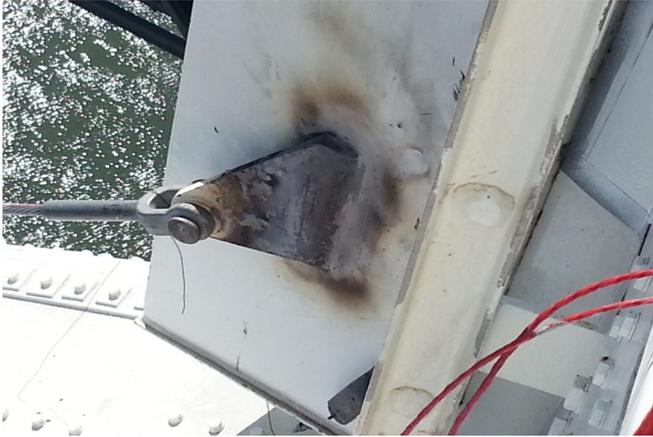
This QA Inspector randomly observed ABF welder Jose Torres and welding personnel utilize a pulling come along on lugs #3 and #4 to move each plate inward approximately ½” in accordance with RFI-003248R01. Prior to the application of mechanical force, each plate was heated along the length of, and just above, the weld connection with QC Inspector William Sherwood monitoring the temperature to ensure the lugs did not exceed 595°C (1100°F) in accordance with RWR-201304-10. Upon achieving ½”, the lug was allowed to cool to ambient temperature. This QA Inspector observed QC perform Magnetic Particle (MT) Inspection of the heat site and weld of the lug and noted that no indications were present.

This QA Inspector discussed with Caltrans Construction Engineer Loraine Woo that the 1/2" lug #2 was moved, appeared to be inadequate and may require further work.
