**DEPARTMENT OF TRANSPORTATION**

Contract #: 04-0120F4Cty: SF/ALA Rte: 80 PM: 13.2/13.9File #: 1.28**WELDING INSPECTION REPORT****Resident Engineer:** Casey, William**Address:** 333 Burma Road**City:** Oakland, CA 94607**Report No:** WIR-029471**Date Inspected:** 24-Apr-2013**Project Name:** SAS Superstructure**OSM Arrival Time:** 700**Prime Contractor:** American Bridge/Fluor Enterprises, a JV**OSM Departure Time:** 1730**Contractor:** American Bridge/Fluor Enterprises, a JV**Location:** Job Site**CWI Name:** Bernie Docena**CWI Present:** Yes No**Inspected CWI report:** Yes No N/A**Rod Oven in Use:** Yes No N/A**Electrode to specification:** Yes No N/A**Weld Procedures Followed:** Yes No N/A**Qualified Welders:** Yes No N/A**Verified Joint Fit-up:** Yes No N/A**Approved Drawings:** Yes No N/A**Approved WPS:** Yes No N/A**Delayed / Cancelled:** Yes No N/A**Bridge No:** 34-0006**Component:** SAS Tower**Summary of Items Observed:**

## Ultrasonic Testing of Tower Electroslag Welds (ESW)

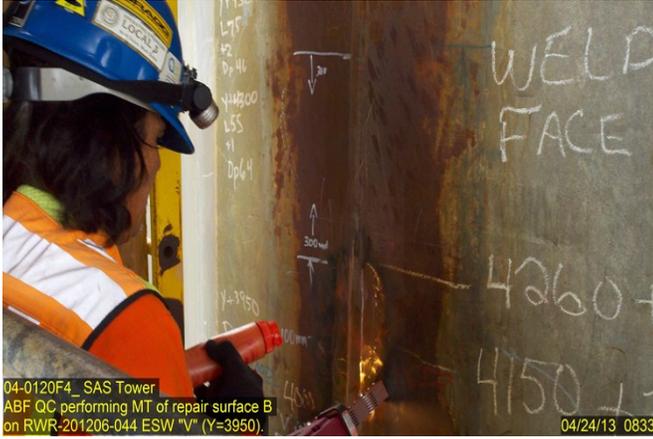
QA observed at random intervals, ABF/JV welder Mike Jimenez (WID-4671) performing carbon arc air gouging of ESW welds for defect removal on ESW weld designated as F. Location of excavation was noted as:

ESW E -045 "F" Face B

Y= (Original) 3920mm. Excavated 3870~4050.

After excavation and grinding to bright metal ABF Quality Control (QC) Inspector Bernie Docena was observed performing MT testing of the excavation to ensure all discontinuities were removed prior to welding. The QA Inspector also performed MT inspection of the excavation and did not observe any weld defects. Repair area is to be inspected with UT/MT after weld repair and the required cooling time of 48 hrs as described in section 12 of AWS D1.5-02. See TL-6028 for information on items inspected on this date.
