**DEPARTMENT OF TRANSPORTATION**

Contract #: 04-0120F4Cty: SF/ALA Rte: 80 PM: 13.2/13.9File #: 1.28**WELDING INSPECTION REPORT****Resident Engineer:** Casey, William**Address:** 333 Burma Road**City:** Oakland, CA 94607**Report No:** WIR-029472**Date Inspected:** 25-Mar-2013**Project Name:** SAS Superstructure**OSM Arrival Time:** 700**Prime Contractor:** American Bridge/Fluor Enterprises, a JV**OSM Departure Time:** 1730**Contractor:** American Bridge/Fluor Enterprises, a JV**Location:** Jobsite**CWI Name:** See below**CWI Present:** Yes No**Inspected CWI report:** Yes No N/A**Rod Oven in Use:** Yes No N/A**Electrode to specification:** Yes No N/A**Weld Procedures Followed:** Yes No N/A**Qualified Welders:** Yes No N/A**Verified Joint Fit-up:** Yes No N/A**Approved Drawings:** Yes No N/A**Approved WPS:** Yes No N/A**Delayed / Cancelled:** Yes No N/A**Bridge No:** 34-0006**Component:** OBG**Summary of Items Observed:**

# WELDING INSPECTION REPORT

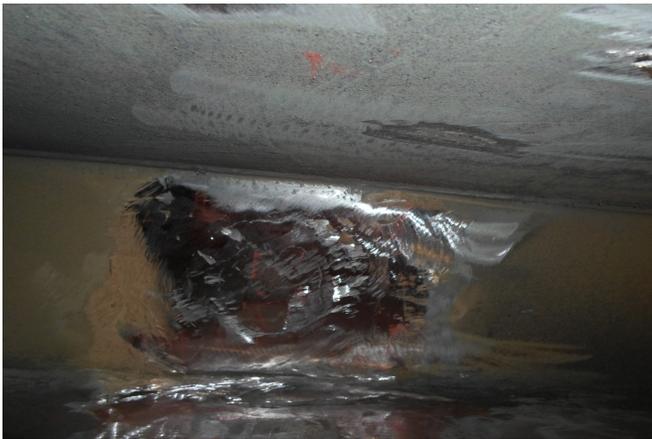
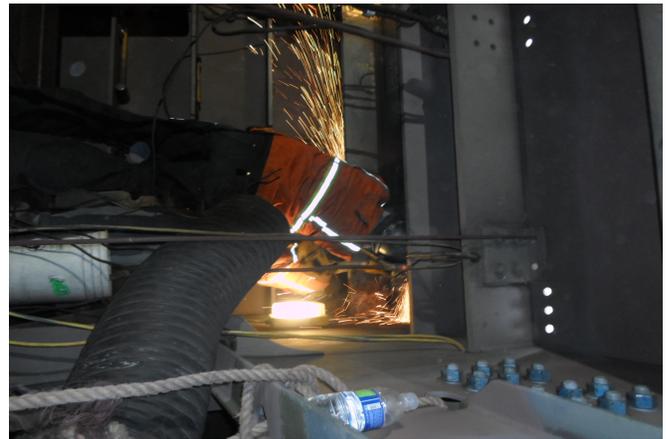
The digital photographs below illustrate some of the work activities observed on this date:
