DEPARTMENT OF TRANSPORTATION

Quality Assurance and Source Inspection

Contract #: 04-0120F4Cty: SF/ALA Rte: 80 PM: 13.2/13.9File #: 1.28**WELDING INSPECTION REPORT****Resident Engineer:** Casey, William**Address:** 333 Burma Road**City:** Oakland, CA 94607**Report No:** WIR-029491**Date Inspected:** 29-Apr-2013**Project Name:** SAS Superstructure**OSM Arrival Time:** 700**Prime Contractor:** American Bridge/Fluor Enterprises, a JV**OSM Departure Time:** 1730**Contractor:** American Bridge/Fluor Enterprises, a JV**Location:** Job Site**CWI Name:** Andrew Keech, Bernie Docena**CWI Present:** Yes No**Inspected CWI report:** Yes No N/A**Rod Oven in Use:** Yes No N/A**Electrode to specification:** Yes No N/A**Weld Procedures Followed:** Yes No N/A**Qualified Welders:** Yes No N/A**Verified Joint Fit-up:** Yes No N/A**Approved Drawings:** Yes No N/A**Approved WPS:** Yes No N/A**Delayed / Cancelled:** Yes No N/A**Bridge No:** 34-0006**Component:** SAS Tower**Summary of Items Observed:**

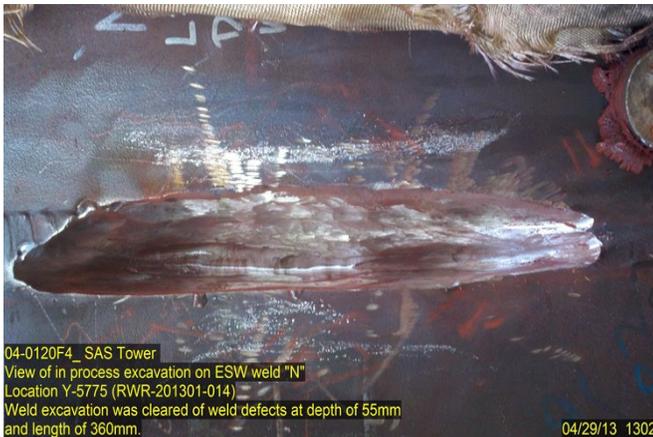
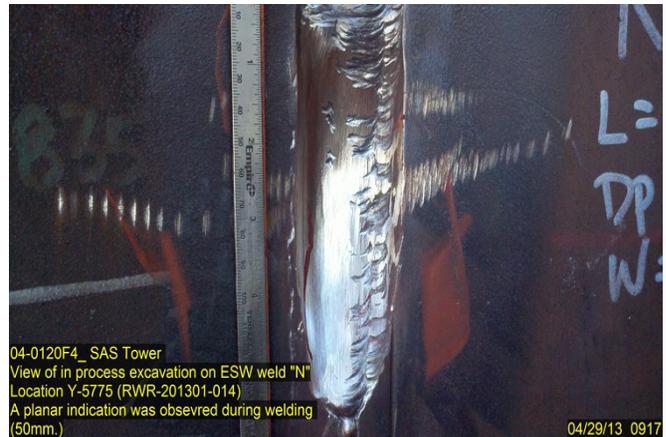
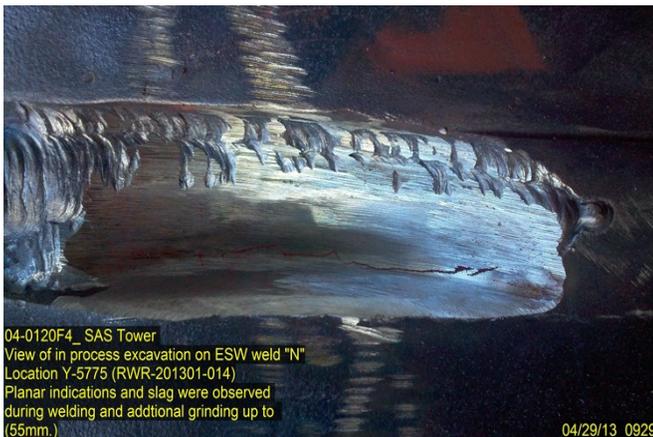
observed a planar type indication in the weld repair area of ESW "N" Face A @ Y-5775, depth of 47mm. QC Inspector Andrew Keech and the QA Inspector verified the indication with MT after some grinding. The welder attempted to remove the planar indication with additional grinding, but planar and slag indications still remained. The welder and QC Inspector discussed that they would need to continue grinding to remove all indications and will exceed the maximum depth of excavation (85% of weld thickness) for the 60mm (120°tee) weld as described in the request for welding repair. The QA Inspector informed QA Lead Inspector Danny Reyes of the discrepancy and the plan of action that the contractor would take. WID-4671 performed additional excavating until the indication appeared to be removed at 55mm deep. After grinding to bright metal the QC Inspector performed MT testing of the excavation to ensure all discontinuities were removed prior to welding. The QA Inspector also performed MT inspection of the repair and did not observe any additional indications. Location of new excavation was:

ESW "N", Face A

Y= (Original) 5775mm (Excavated 5600~5975)

L= 360mm

W= 50mm

D= 55mm* after acceptance

The QA/QC Inspector discussed with the welder the importance of maintaining required 300° degrees Fahrenheit preheat during welding. Welding continued on the shift and still remains in-process. *Note- ABF QC Inspector Andrew Keech issued a Non-Conformance report for Welder #4671 exceeding the maximum depth of excavation (85% of weld thickness) as per the approved RWR. Please see TL-6028 for additional details on items inspected.
