Contract #: 04-0120F4Cty: SF/ALA Rte: 80 PM: 13.2/13.9File #: 1.28**WELDING INSPECTION REPORT****Resident Engineer:** Casey, William**Address:** 333 Burma Road**City:** Oakland, CA 94607**Report No:** WIR-029492**Date Inspected:** 27-Apr-2013**Project Name:** SAS Superstructure**OSM Arrival Time:** 700**Prime Contractor:** American Bridge/Fluor Enterprises, a JV**OSM Departure Time:** 1530**Contractor:** American Bridge/Fluor Enterprises, a JV**Location:** Job Site**CWI Name:** Andrew Keech, Bernie Docena**CWI Present:** Yes No**Inspected CWI report:** Yes No N/A**Rod Oven in Use:** Yes No N/A**Electrode to specification:** Yes No N/A**Weld Procedures Followed:** Yes No N/A**Qualified Welders:** Yes No N/A**Verified Joint Fit-up:** Yes No N/A**Approved Drawings:** Yes No N/A**Approved WPS:** Yes No N/A**Delayed / Cancelled:** Yes No N/A**Bridge No:** 34-0006**Component:** SAS Tower**Summary of Items Observed:**

Ultrasonic Testing of Tower Electroslag Welds (ESW)

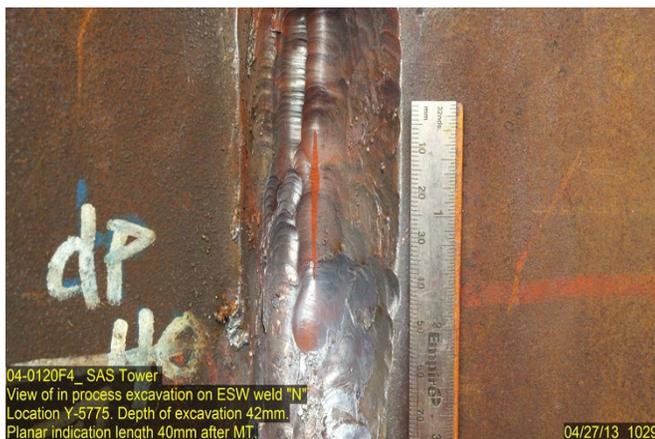
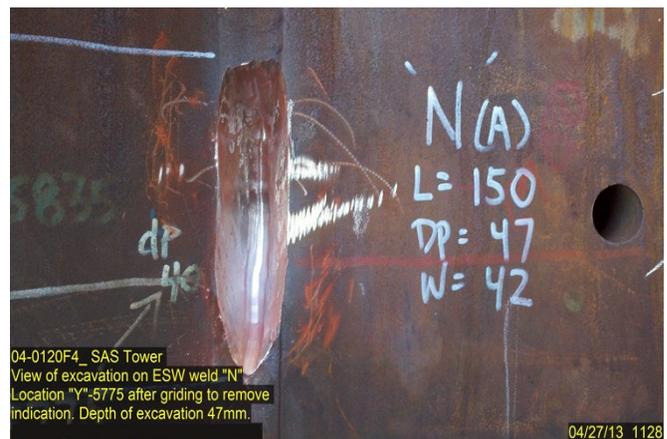
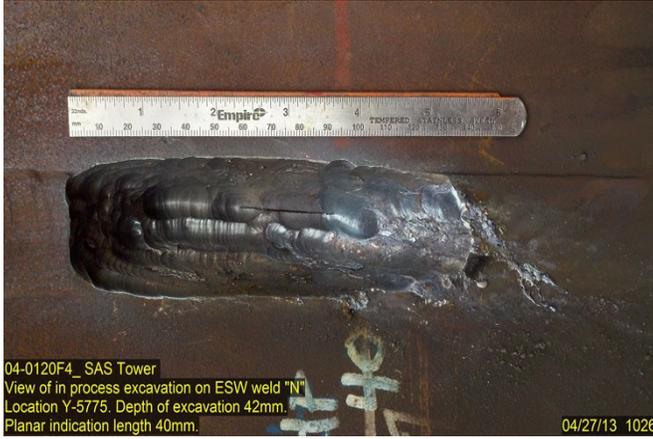
ESW N-041, ESW N-Face A:

QA observed at random intervals, ABF/JV welder Mike Jimenez (WID-4671) performing carbon arc air gouging of ESW welds for defect removal on ESW weld designated as V. Location of excavation was noted as:

The QA Inspector and ABF Quality Control Inspector (QC) Bernie Docena were informed by WID-4671 that he had observed a planar type indication at approx 42mm deep during excavation. QA measured the indication at 40mm long. The QC Inspector stated that the indication appeared to be non-fusion type indication. WID-4671 performed additional excavating until the indication appeared to be removed at 47 mm deep. After grinding to bright the QC Inspector performed MT testing of the excavation to ensure all discontinuities were removed prior to welding. The QA Inspector also performed MT inspection of the excavation and did not observe any weld defects. Welding commenced on the repair at approx. 1300 and is in-process. The repair area will be reinspected with UT/MT after welding and the required cooling time of 48 hrs as detailed in section 12. Please see TL-6028 for additional details on items inspected.
