DEPARTMENT OF TRANSPORTATION

Contract #: 04-0120F4Cty: SF/ALA Rte: 80 PM: 13.2/13.9File #: 1.28**WELDING INSPECTION REPORT****Resident Engineer:** Casey, William**Address:** 333 Burma Road**City:** Oakland, CA 94607**Report No:** WIR-029508**Date Inspected:** 08-Apr-2013**Project Name:** SAS Superstructure**OSM Arrival Time:** 700**Prime Contractor:** American Bridge/Fluor Enterprises, a JV**OSM Departure Time:** 1730**Contractor:** American Bridge/Fluor Enterprises, a JV**Location:** Jobsite**CWI Name:** See below**CWI Present:** Yes No**Inspected CWI report:** Yes No N/A**Rod Oven in Use:** Yes No N/A**Electrode to specification:** Yes No N/A**Weld Procedures Followed:** Yes No N/A**Qualified Welders:** Yes No N/A**Verified Joint Fit-up:** Yes No N/A**Approved Drawings:** Yes No N/A**Approved WPS:** Yes No N/A**Delayed / Cancelled:** Yes No N/A**Bridge No:** 34-0006**Component:****Summary of Items Observed:**

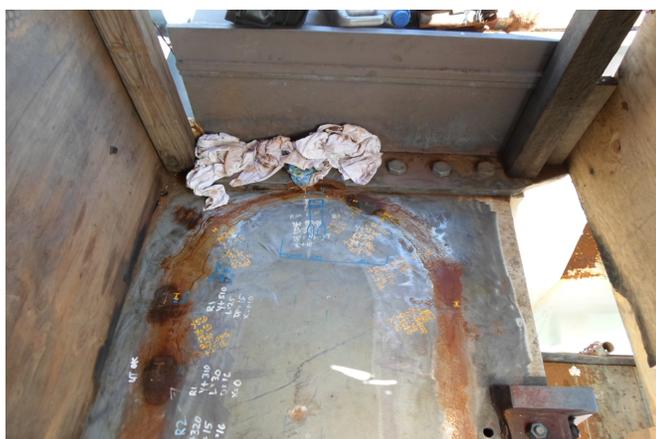
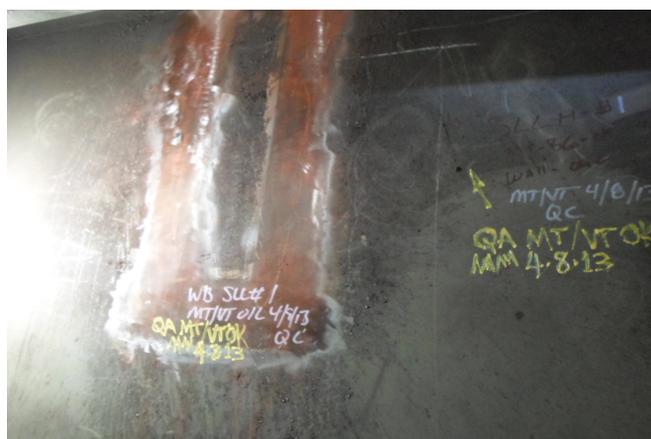
The digital photographs below illustrate some of the work activities observed on this date:
