DEPARTMENT OF TRANSPORTATION

Contract #: 04-0120F4Cty: SF/ALA Rte: 80 PM: 13.2/13.9File #: 1.28**WELDING INSPECTION REPORT****Resident Engineer:** Casey, William**Address:** 333 Burma Road**City:** Oakland, CA 94607**Report No:** WIR-029509**Date Inspected:** 04-Apr-2013**Project Name:** SAS Superstructure**OSM Arrival Time:** 700**Prime Contractor:** American Bridge/Fluor Enterprises, a JV**OSM Departure Time:** 1730**Contractor:** American Bridge/Fluor Enterprises, a JV**Location:** Jobsite**CWI Name:** See below**CWI Present:** Yes No**Inspected CWI report:** Yes No N/A**Rod Oven in Use:** Yes No N/A**Electrode to specification:** Yes No N/A**Weld Procedures Followed:** Yes No N/A**Qualified Welders:** Yes No N/A**Verified Joint Fit-up:** Yes No N/A**Approved Drawings:** Yes No N/A**Approved WPS:** Yes No N/A**Delayed / Cancelled:** Yes No N/A**Bridge No:** 34-0006**Component:** OBG**Summary of Items Observed:**

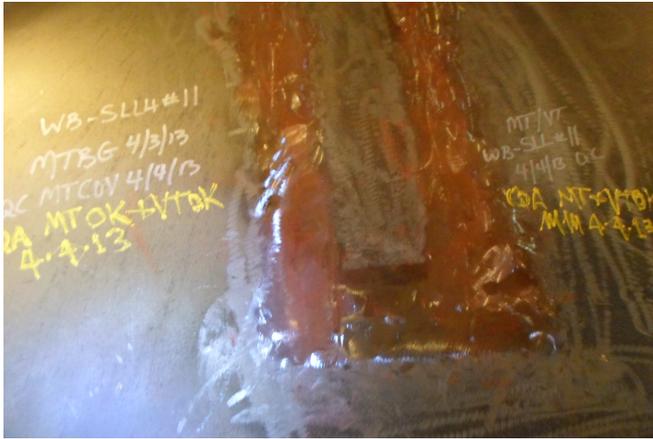
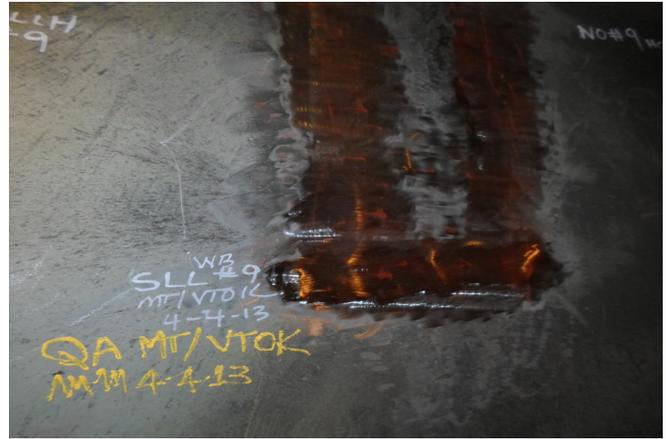
The digital photographs on page three (3) of this report illustrate some of the work activities observed on this date:
