DEPARTMENT OF TRANSPORTATION

Quality Assurance and Source Inspection

Contract #: 04-0120F4Cty: SF/ALA Rte: 80 PM: 13.2/13.9File #: 1.28**WELDING INSPECTION REPORT****Resident Engineer:** Casey, William**Address:** 333 Burma Road**City:** Oakland, CA 94607**Report No:** WIR-029510**Date Inspected:** 05-Apr-2013**Project Name:** SAS Superstructure**OSM Arrival Time:** 700**Prime Contractor:** American Bridge/Fluor Enterprises, a JV**OSM Departure Time:** 1730**Contractor:** American Bridge/Fluor Enterprises, a JV**Location:** Jobsite**CWI Name:** See below**CWI Present:** Yes No**Inspected CWI report:** Yes No N/A**Rod Oven in Use:** Yes No N/A**Electrode to specification:** Yes No N/A**Weld Procedures Followed:** Yes No N/A**Qualified Welders:** Yes No N/A**Verified Joint Fit-up:** Yes No N/A**Approved Drawings:** Yes No N/A**Approved WPS:** Yes No N/A**Delayed / Cancelled:** Yes No N/A**Bridge No:** 34-0006**Component:** OBG**Summary of Items Observed:**

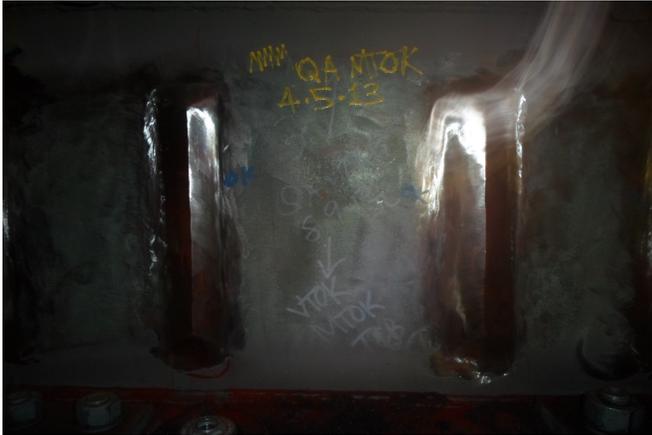
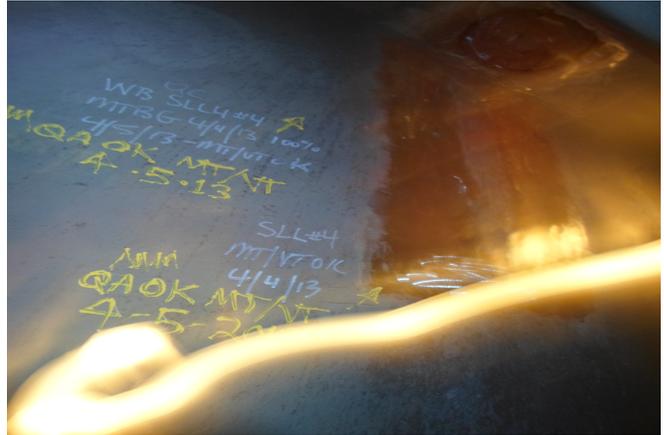
The digital photographs below illustrate some of the work activities observed on this date:
