DEPARTMENT OF TRANSPORTATION

Contract #: 04-0120F4Cty: SF/ALA Rte: 80 PM: 13.2/13.9File #: 1.28**WELDING INSPECTION REPORT****Resident Engineer:** Casey, William**Address:** 333 Burma Road**City:** Oakland, CA 94607**Report No:** WIR-029512**Date Inspected:** 09-Apr-2013**Project Name:** SAS Superstructure**OSM Arrival Time:** 700**Prime Contractor:** American Bridge/Fluor Enterprises, a JV**OSM Departure Time:** 1730**Contractor:** American Bridge/Fluor Enterprises, a JV**Location:** Jobsite**CWI Name:** See below**CWI Present:** Yes No**Inspected CWI report:** Yes No N/A**Rod Oven in Use:** Yes No N/A**Electrode to specification:** Yes No N/A**Weld Procedures Followed:** Yes No N/A**Qualified Welders:** Yes No N/A**Verified Joint Fit-up:** Yes No N/A**Approved Drawings:** Yes No N/A**Approved WPS:** Yes No N/A**Delayed / Cancelled:** Yes No N/A**Bridge No:** 34-0006**Component:** OBG**Summary of Items Observed:**

WELDING INSPECTION REPORT

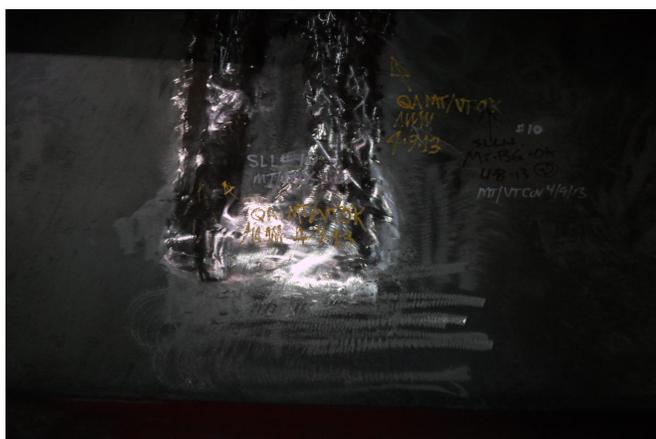
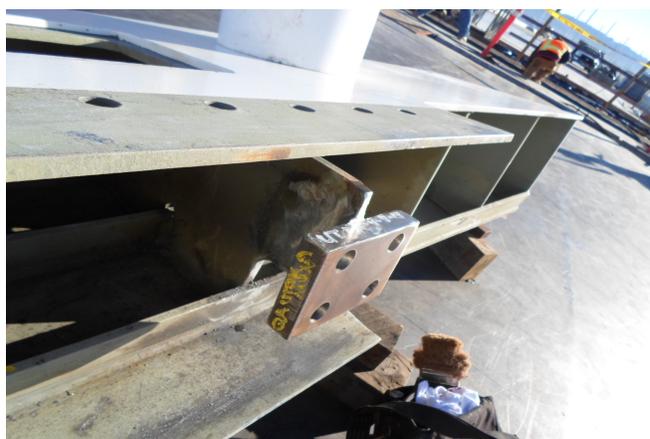
The digital photographs below illustrate some of the work activities observed on this date:
