DEPARTMENT OF TRANSPORTATION

Contract #: 04-0120F4Cty: SF/ALA Rte: 80 PM: 13.2/13.9File #: 99.28**WELDING INSPECTION REPORT****Resident Engineer:** Casey, William**Address:** 333 Burma Road**City:** Oakland, CA 94607**Report No:** WIR-029546**Date Inspected:** 02-May-2013**Project Name:** SAS Superstructure**OSM Arrival Time:** 700**Prime Contractor:** American Bridge/Fluor Enterprises, a JV**OSM Departure Time:** 1530**Contractor:** USA Hoist**Location:** USA Hoist, Crest Hill, IL

Bridge No: 34-0006**Component:** Elevator Cab frame assembly**Summary of Items Observed:**

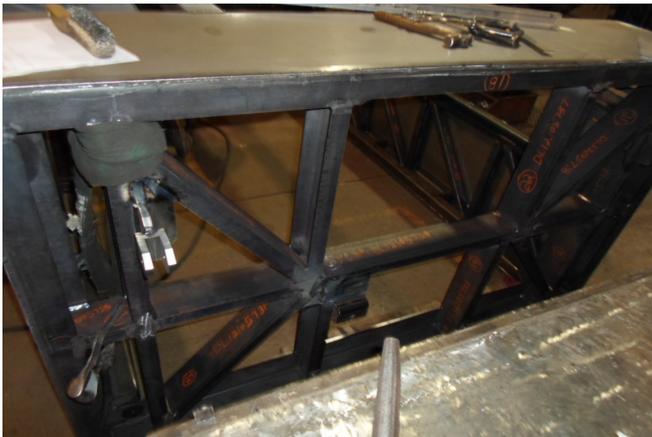
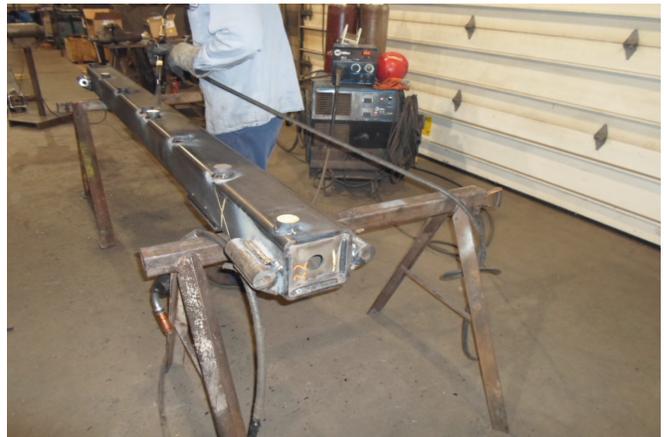
It was noted by this QAI that, per the shop drawing weld symbols, welds throats were undersized of joints requiring skewed fillet and flare-bevel welds of pipe (round tubing) sections at the ends of the tower poles where the sections will subsequently be high-strength bolted together.

This QAI visually viewed the welding of the Elevator Cab frame assembly and noted the following discrepancies: Welds were missing on the top sides of plates #13 (2 total); Welds were missing at the back side of plate item #68 to C4x5.4 channels #20 and #24; Sheet steel skins #3 (2 total) and their associated welds to 'toe-to-toe' formed-channel items #27 and #58 were missing; The weld of plate item #63 to channel item #11 was undersized; The ends of item #52 were not properly terminated (no welds existed at the longitudinal sides at the ends) as required for intermittent type welds.

It was noted by this QAI that all welds that were observed displayed a quality workmanship finish, disregarding the above-mentioned sizing discrepancies on this date.

This QAI notified and showed the above-mentioned discrepancies to USA Hoist's Engineer and Shop Foreman towards getting the issues resolved and the welds completed. The additional welding work required for the Elevator Cab was begun this day, but not completed.
