DEPARTMENT OF TRANSPORTATION

Quality Assurance and Source Inspection

Contract #: 04-0120F4Cty: SF/ALA Rte: 80 PM: 13.2/13.9File #: 1.28**WELDING INSPECTION REPORT****Resident Engineer:** Casey, William**Address:** 333 Burma Road**City:** Oakland, CA 94607**Report No:** WIR-029666**Date Inspected:** 11-Jun-2013**Project Name:** SAS Superstructure**OSM Arrival Time:** 700**Prime Contractor:** American Bridge/Fluor Enterprises, a JV**OSM Departure Time:** 1730**Contractor:** American Bridge/Fluor Enterprises, a JV**Location:** Job Site**CWI Name:** See below.**CWI Present:** Yes No**Inspected CWI report:** Yes No N/A**Rod Oven in Use:** Yes No N/A**Electrode to specification:** Yes No N/A**Weld Procedures Followed:** Yes No N/A**Qualified Welders:** Yes No N/A**Verified Joint Fit-up:** Yes No N/A**Approved Drawings:** Yes No N/A**Approved WPS:** Yes No N/A**Delayed / Cancelled:** Yes No N/A**Bridge No:** 34-0006**Component:** Tower Electroslag Welds**Summary of Items Observed:**

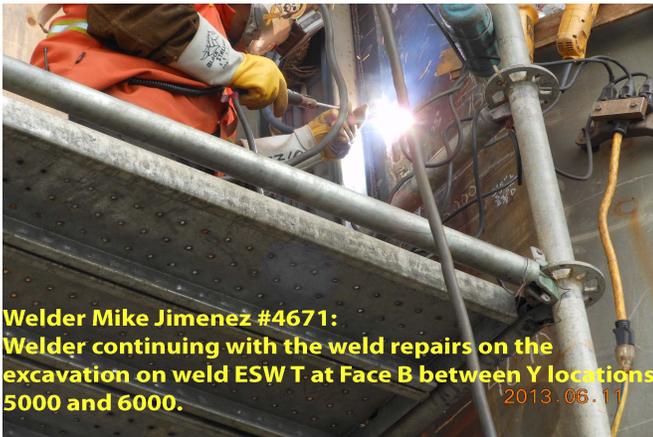
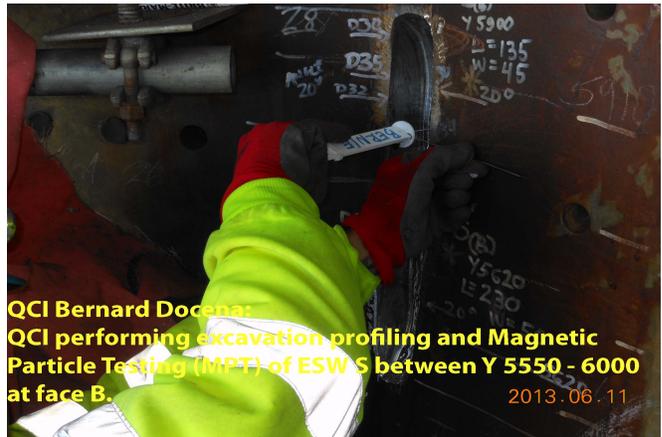
The welder was observed continuing with the weld repairs on Ultrasonic Testing rejected indications on weld ESW T at Face B between Y locations 5000 and 6000. The welder was observed preheating the weld to 350 degrees Fahrenheit prior to welding using the Miller ProHeat 35 with heat induction blankets. The welder utilized the Welding Procedure Specification (WPS) ABF-WPS-D15-1000-Repair Rev.3 for Shield Metal Arc Welding (SMAW). The welding parameters were verified by QC Inspector Bernard Docena throughout the day and they appeared to be in compliance with the WPS noted above.

The welder was observed continuing with the excavation of weld ESW S at Face B by Carbon Arc Gouging (CAG) at Y locations 5620 and 5900. The excavations were in way of rejects noted with Ultrasonic Testing Shear Wave (UTSW). After Carbon Arc Gouging (CAG) the weld excavation was then ground to shiny metal by an ABF apprentice and was Magnetic Particle Tested (MPT) by this QA Inspector and QC Inspector Bernard Docena. A transverse indication was noted in the excavated area and was excavated out at 45mm Deep. Indications at Y locations 5620 and 5900 were combined for final excavation length of 450mm. The excavation was Magnetic Particle Tested and was accepted.

- Face B, Weld Excavation at Y5550 - 6000.
 - 450 x 50 x 45deep (MPT Accept)
