Contract #: 04-0120F4Cty: SF/ALA Rte: 80 PM: 13.2/13.9File #: 99.28**WELDING INSPECTION REPORT**

Report No: WIR-029672
Date Inspected: 10-Jun-2013

Project Name: SAS Superstructure
Prime Contractor: American Bridge/Fluor Enterprises, a JV
Contractor: USA Hoist

CWI Name:	Robert Zimny	CWI Present:	Yes	No
Inspected CWI report:	Yes No N/A	Rod Oven in Use:	Yes No N/A	
Electrode to specification:	Yes No N/A	Weld Procedures Followed:	Yes No N/A	
Qualified Welders:	Yes No N/A	Verified Joint Fit-up:	Yes No N/A	
Approved Drawings:	Yes No N/A	Approved WPS:	Yes No N/A	
		Delayed / Cancelled:	Yes No N/A	
Bridge No:	34-0006	Component:	SAS Tower Elevator

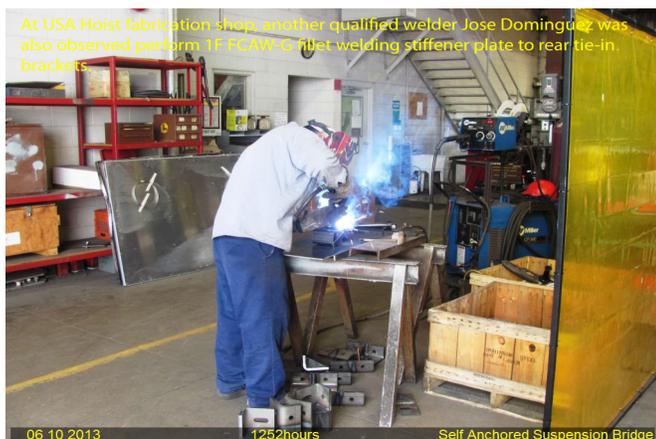
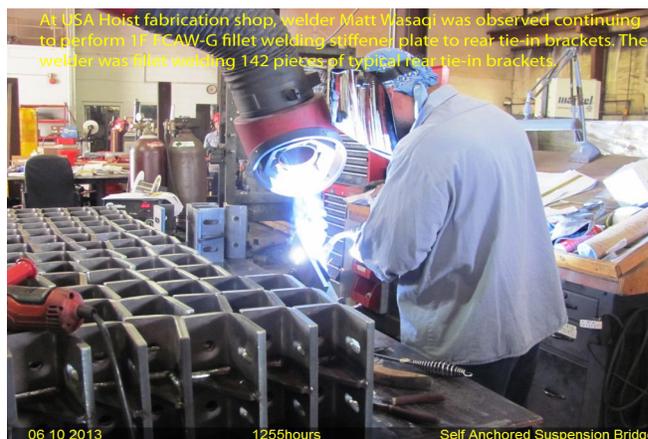
At USA Hoist assembly shop, this QA randomly observed USA Hoist welder Matt Wasiqi continuing to perform 1F fillet welding between the 4 1/2" x 3' x 3/8" thick stiffener plate and 5" x 3 1/2" x 1/2" thick bent plate rear tie in bracket. The 1/4" fillet weld is being welded per USA shop drawing 914204-11 and there is a total 142 pieces of this bracket. The welder was noted using gas shielded FCAW-G with 1.1mm E71T-1C Familiarc DW-50 wire electrode implementing USA Hoist Welding Procedure Specification FCAW 3210. The shielding gas being used was noted a combination of 75% Argon and 25% CO2 with flow rate of 35 CFH. During the shift, the working welding parameters were measured 29 volts and 230 amperes which deemed in compliance to the project requirements. At the end of the shift, 1/4" fillet welding on all sides of the stiffener plate to the 142 pieces of rear tie in bracket was completed.

At the same assembly shop, another USA Hoist qualified welder Jose Dominguez was observed fillet welding the same rear tie-in brackets for the tower elevator as mentioned above. The welder was noted using the same process and implementing the same welding procedure specification. The welder was noted using gas shielded FCAW-G with 1.1mm E71T-1C Familiarc DW-50 wire electrode implementing USA Hoist Welding Procedure Specification FCAW 3210. The shielding gas being used was noted a combination of 75% Argon and 25% CO2 with flow rate of 35 CFH. During the shift, the working welding parameters were measured 28 volts and 225 amperes which deemed in compliance to the project requirements. This QA randomly checked the workmanship and measured the

required 1/4" fillet on all sides of the stiffener which was found in compliance to the requirement. With the two welders welding side by side on the rear tie-in brackets, all 142 pieces of the brackets were completed.

At USA Hoist assembly shop, this QA randomly observed USA certified welder Manolo Luna continuing to grind and clean the fillet weld repairs on the 1 3/4" diameter x 7/8" thick rack pad to the 6" x 6" x 3/8" thick tube steel mast. While the welder was grinding/cleaning the fillet weld repairs, this QA has randomly verified the size and the profile of the repairs which was found acceptable to the required 1/4" fillet.

At the same assembly shop, USA Hoist have received the 142 pieces of bent plate tower tie-in brackets per USA Hoist drawing #914204-18 and 152 pieces of bent plate front tie-in brackets per USA Hoist drawing #914204-15 from the other shop that made the bending few days ago. According to the USA Hoist shop foreman Genaro Ulloa, when they measured the degree of bend on those mentioned brackets they found out that it was not up to the required bend. Due to this issue, all the brackets just mentioned were sent back to the shop where they were done and to bend them to the required 90 degree. These two different brackets will be welded with stiffener on the middle of each bracket.
