DEPARTMENT OF TRANSPORTATION

Quality Assurance and Source Inspection

Contract #: 04-0120F4Cty: SF/ALA Rte: 80 PM: 13.2/13.9File #: 99.28**WELDING INSPECTION REPORT****Resident Engineer:** Casey, William**Address:** 333 Burma Road**City:** Oakland, CA 94607**Report No:** WIR-029709**Date Inspected:** 05-Jun-2013**Project Name:** SAS Superstructure**OSM Arrival Time:** 1100**Prime Contractor:** American Bridge/Fluor Enterprises, a JV**OSM Departure Time:** 1730**Contractor:** American Bridge/Fluor Enterprises, a JV**Location:** Jobsite**CWI Name:** See below**CWI Present:** Yes No**Inspected CWI report:** Yes No N/A**Rod Oven in Use:** Yes No N/A**Electrode to specification:** Yes No N/A**Weld Procedures Followed:** Yes No N/A**Qualified Welders:** Yes No N/A**Verified Joint Fit-up:** Yes No N/A**Approved Drawings:** Yes No N/A**Approved WPS:** Yes No N/A**Delayed / Cancelled:** Yes No N/A**Bridge No:** 34-0006**Component:** Eastbound OBG deck; Piping welds**Summary of Items Observed:**

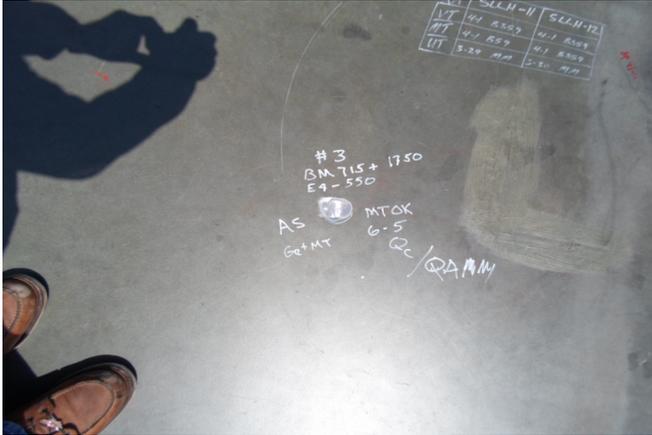
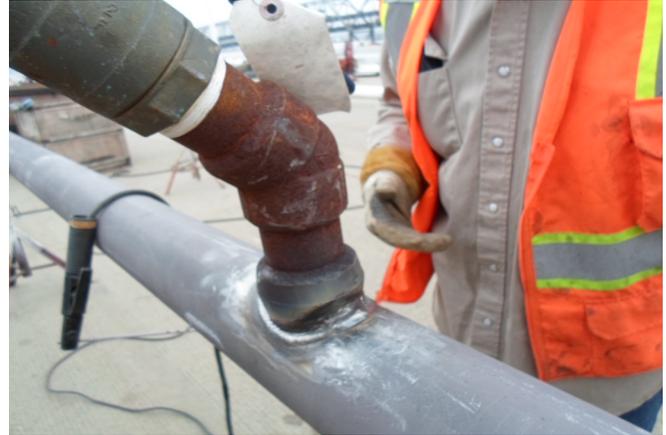
This QAI witnessed F.W. Spencer welder Barry Mullaney #6520 perform the welding of 4" diameter pipe to sockolet base for compressed air joint location 1/CA2/PP128/NW. Mr. Mullaney also performed the welding of 2-1/2" diameter pipe to flange for joint location 67/2.5/PP126/NW as well as 2-1/2" diameter pipe to sockolet base

for domestic water joint location 1/DWI/PP128/NW. All welding was performed as per F.W.Spencer WPS 1-12-1 utilizing E6010 electrodes for root pass and E7018 electrodes for fill and cap passes. AB/F QC Inspector Fred Michels was present, monitoring the WPS parameters of welding in process.
