Contract #: 04-0120F4Cty: SF/ALA Rte: 80 PM: 13.2/13.9File #: 99.28**WELDING INSPECTION REPORT****Resident Engineer:** Casey, William**Address:** 333 Burma Road**City:** Oakland, CA 94607**Report No:** WIR-029729**Date Inspected:** 10-Jun-2013**Project Name:** SAS Superstructure**OSM Arrival Time:** 700**Prime Contractor:** American Bridge/Fluor Enterprises, a JV**OSM Departure Time:** 1730**Contractor:** American Bridge/Fluor Enterprises, a JV**Location:** Jobsite**CWI Name:** See below**CWI Present:** Yes No**Inspected CWI report:** Yes No N/A**Rod Oven in Use:** Yes No N/A**Electrode to specification:** Yes No N/A**Weld Procedures Followed:** Yes No N/A**Qualified Welders:** Yes No N/A**Verified Joint Fit-up:** Yes No N/A**Approved Drawings:** Yes No N/A**Approved WPS:** Yes No N/A**Delayed / Cancelled:** Yes No N/A**Bridge No:** 34-0006**Component:** Eastbound OBG deck; Bikepath gate landing;**Summary of Items Observed:**

WELDING INSPECTION REPORT

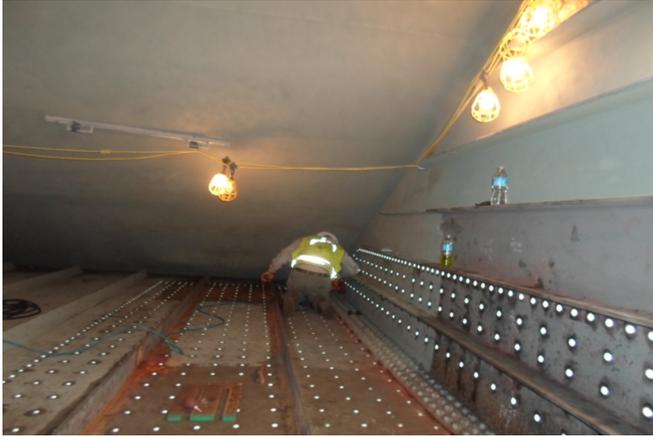
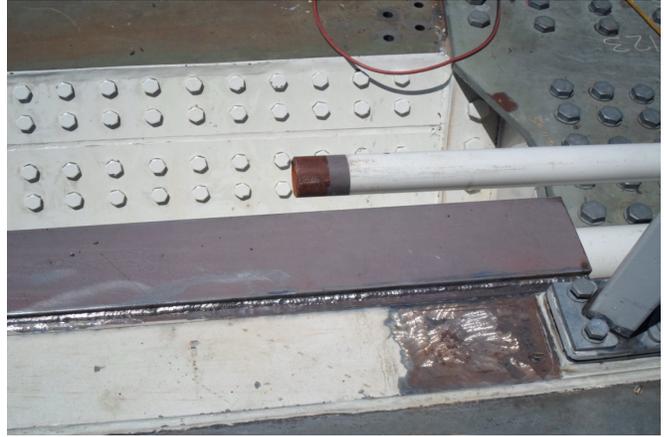
Fillet welding was in progress and not completed this day of Gate ledger angle to Bikepath frame edge at location PP123. The welding was being performed by AB/F welder Jose Torres #6235 utilizing E7018 electrodes as per the AB/F WPS F1200A. The AB/F QC William Sherwood was present and monitoring the WPS parameters of the

welding in progress.
