**DEPARTMENT OF TRANSPORTATION**

Contract #: 04-0120F4Cty: SF/ALA Rte: 80 PM: 13.2/13.9File #: 99.28**WELDING INSPECTION REPORT****Resident Engineer:** Casey, William**Address:** 333 Burma Road**City:** Oakland, CA 94607**Report No:** WIR-029730**Date Inspected:** 11-Jun-2013**Project Name:** SAS Superstructure**OSM Arrival Time:** 700**Prime Contractor:** American Bridge/Fluor Enterprises, a JV**OSM Departure Time:** 1530**Contractor:** American Bridge/Fluor Enterprises, a JV**Location:** Jobsite**CWI Name:** See below**CWI Present:** Yes No**Inspected CWI report:** Yes No N/A**Rod Oven in Use:** Yes No N/A**Electrode to specification:** Yes No N/A**Weld Procedures Followed:** Yes No N/A**Qualified Welders:** Yes No N/A**Verified Joint Fit-up:** Yes No N/A**Approved Drawings:** Yes No N/A**Approved WPS:** Yes No N/A**Delayed / Cancelled:** Yes No N/A**Bridge No:** 34-0006**Component:** Eastbound OBG Deck; Bikepath gate landing**Summary of Items Observed:**

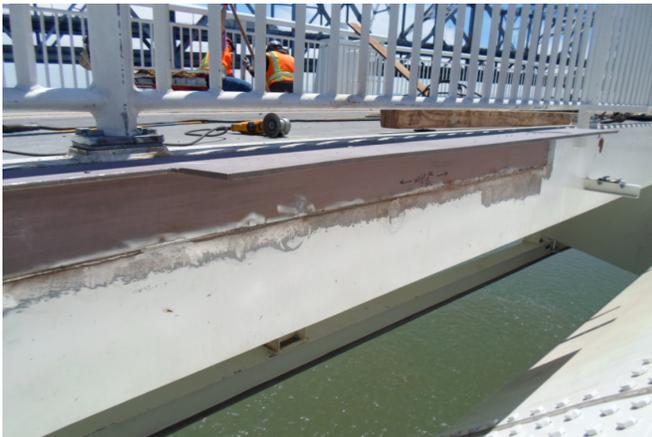
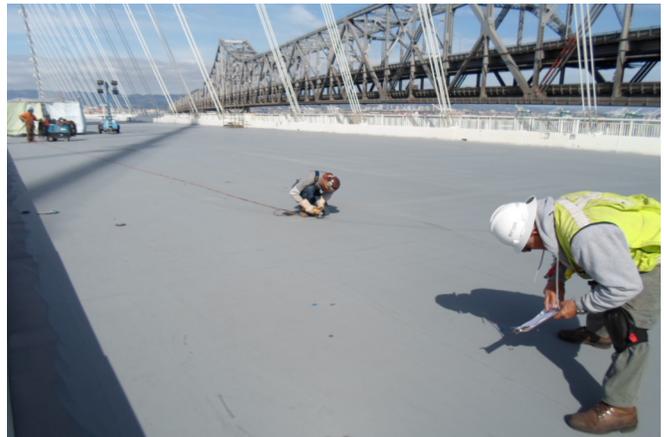
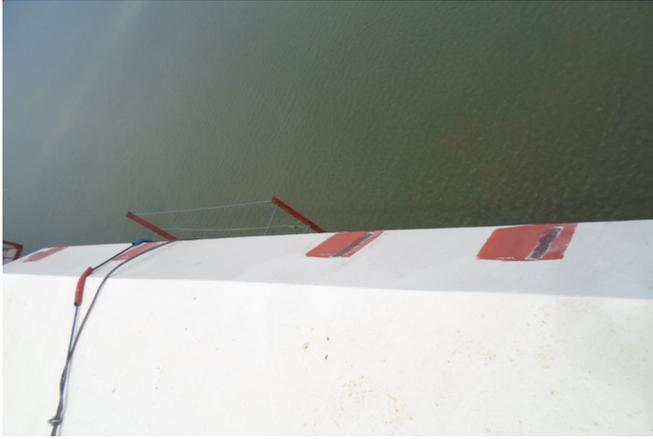
being performed. The AB/F QC had performed his final visual inspection of the above-mentioned fillet welds based on an interpretation that the design drawings were indicating a 7mm size. This QAI found the welds to be undersized based on the a 9mm weld size being shown per Sections A1 and A2 of ZPMC Bikepath Panel Assembly drawing 708R10, sheet BK5D. The AB/F QC upon re-reviewing the details confirmed consensus with this QAI's interpretation of the drawing's directive and informed AB/F that additional welding would be required to bring those welds into conformance with the contract documents.

This QAI observed the fillet welding of 4 total baseplates in progress to the Westbound OBG Suspension Cable shroud assembly as per AB/F RFI #003350R00. The baseplates are for the subsequent attachment of pipe support assemblies for the 4" diameter Compressed Air piping at the following locations: PP118.5, PP118 (+120), PP119 (-420), PP119.5 (-600). The fillet welds were performed by AB/F welder Richard Garcia #5892 utilizing E7018 electrodes as per AB/F WPSF1200A. AB/F QC Inspector Fred Michels was present, monitoring the WPS parameters of the welding in process.

This QAI performed the visual and MPT verification inspection of completed fillet welds of attachments to the top plate of Crossbeam CB19 for subsequent mounting of piping supports at the following locations: PP126(-3302)/W5(+322), PP126(+1027)/W5(+3005), PP126(+1627)/W5(+3005), PP126(+2227)/W5(+3005), PP126(+600)/W5(+2902), PP126(+600)/W5(-3152), PP126(+1130)/W5(-6010), PP126(+1835)/W5(-6510), PP126(-1460)/E5(+5146), PP126(+1198)/E5(+5908), PP126(-608)/E5(+3092), and PP126(-1019)/E5(+2954). There were no indications noted at this time. See the TL6028 Magnetic Particle Testing report. All the welds appeared to conform to the requirements of the contract documents.
