DEPARTMENT OF TRANSPORTATION

Bridge No: 34-0006**Component:** SAS Tower Elevator**Summary of Items Observed:**

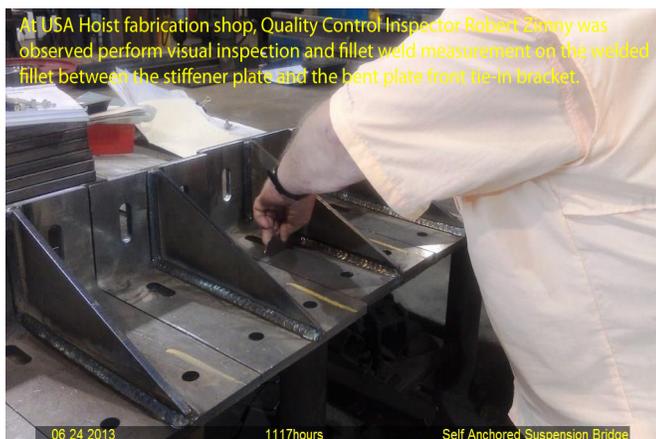
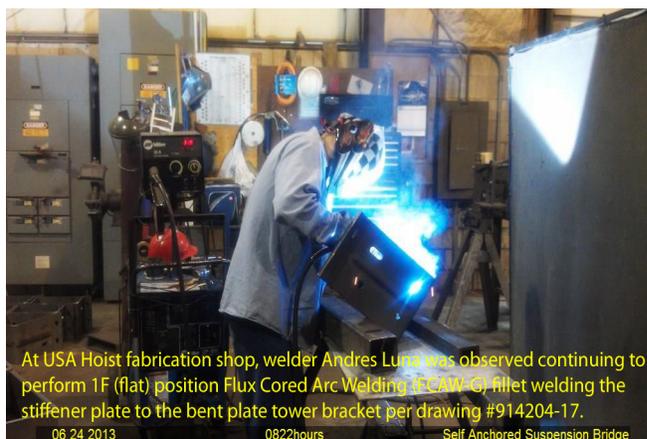
At USA Hoist assembly shop, qualified welder Matt Wasiqi was observed continuing to perform fillet welding the tower tie-in brackets for the tower elevator per USA Hoist shop drawing #914204-17. The welder was noted using the gas shielded Flux Cored Arc Welding (FCAW-G) with 1.1mm E71T-1C Familiarc DW-50 wire electrode and implementing welding procedure specification FCAW 3210. The shielding gas being used was noted a combination of 75% Argon and 25% CO2 with flow rate of 38 CFH. During the shift, the working welding

parameters were measured 29 volts and 235 amperes which deemed in compliance to the project requirements. This QA randomly checked the workmanship and measured the required ¼” fillet on all sides of the stiffener which was found in compliance to the requirement.

Another USA Hoist qualified welder Andres Luna was observed continuing to perform fillet welding the same tower tie-in brackets for the tower elevator as mentioned above. The welder was noted using the same process and implementing the same welding procedure specification. The welder was noted using gas shielded FCAW-G with 1.1mm E71T-1C Familiarc DW-50 wire electrode implementing USA Hoist Welding Procedure Specification FCAW 3210. The shielding gas being used was noted a combination of 75% Argon and 25% CO2 with flow rate of 40 CFH. During the shift, the working welding parameters were measured 27 volts and 200 amperes which deemed in compliance to the project requirements. This QA randomly checked the workmanship and measured the required ¼” fillet on all sides of the stiffener which it was found in compliance to the requirement. With the two welders welding side by side on the tower tie-in brackets, approximately 90 pieces of this type of bracket were completed as of to date.
