DEPARTMENT OF TRANSPORTATION

Contract #: 04-0120F4Cty: SF/ALA Rte: 80 PM: 13.2/13.9File #: 1.28**WELDING INSPECTION REPORT****Resident Engineer:** Casey, William**Address:** 333 Burma Road**City:** Oakland, CA 94607**Report No:** WIR-029750**Date Inspected:** 19-Jun-2013**Project Name:** SAS Superstructure**OSM Arrival Time:** 700**Prime Contractor:** American Bridge/Fluor Enterprises, a JV**OSM Departure Time:** 1530**Contractor:** American Bridge/Fluor Enterprises, a JV**Location:** Jobsite**CWI Name:** See below**CWI Present:** Yes No**Inspected CWI report:** Yes No N/A**Rod Oven in Use:** Yes No N/A**Electrode to specification:** Yes No N/A**Weld Procedures Followed:** Yes No N/A**Qualified Welders:** Yes No N/A**Verified Joint Fit-up:** Yes No N/A**Approved Drawings:** Yes No N/A**Approved WPS:** Yes No N/A**Delayed / Cancelled:** Yes No N/A**Bridge No:** 34-0006**Component:** Bikepath piping; OBG deck surface**Summary of Items Observed:**

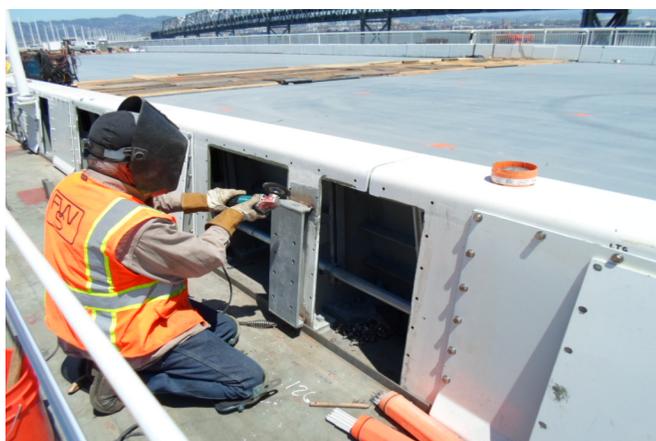
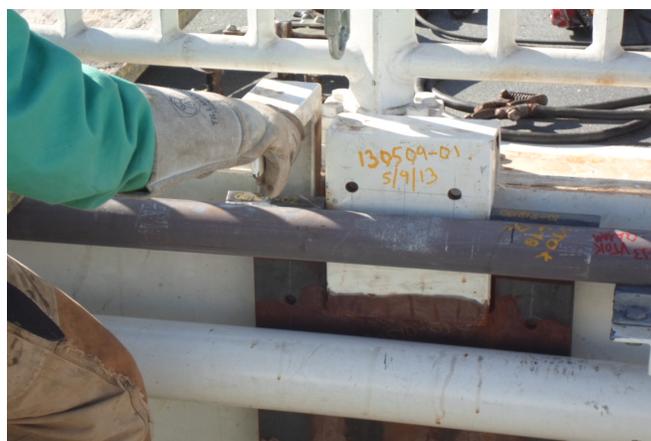
This QAI witnessed the fit-up and welding of the (2nd of 2) axial key plate #061813-02 to the exterior of the 2-1/2" diameter water pipe (for engagement with its pipe restraint support) at location PP28(-1600) of Bikepath. The fit-up and welding was observed being performed of the (1st of 2) axial key plate to the exterior of the adjacent 4" diameter compressed air pipe (for engagement with its pipe restraint support) at location PP28(-1600) of the Bikepath. The welding of these items was performed by F.W.Spencer welder Tim Esquivel #8348 utilizing E7018 electrodes as per the approved WPS #FWS Fillets Murex SFOBB Rev.1. The AB/F Quality Control (QC) inspector Fred Michels was present and monitoring the WPS parameters of the welding in progress. These welds all appeared to meet the requirements of the contract documents.

The galvanizing removal (at areas to be subsequently welded) and fit-up was performed and the welding is in progress of the reinforced W-Tee assembly to the north side of Eastbound E5 Barrier Rail at PP126(+350)/E5. The work was performed by F.W. Spencer welder Barry Mullaney #6520 utilizing E7018 electrodes as per the approved WPS #FWS Fillets Murex SFOBB Rev.1. The AB/F QC Fred Michels was present, monitoring the WPS parameters of the welding in progress. The welding of this assembly at this time is not yet complete. The welds performed so far however, appear to meet the requirements of the contract documents.
