DEPARTMENT OF TRANSPORTATION

Contract #: 04-0120F4Cty: SF/ALA Rte: 80 PM: 13.2/13.9File #: 1.28**WELDING INSPECTION REPORT****Resident Engineer:** Casey, William**Address:** 333 Burma Road**City:** Oakland, CA 94607**Report No:** WIR-029751**Date Inspected:** 20-Jun-2013**Project Name:** SAS Superstructure**OSM Arrival Time:** 700**Prime Contractor:** American Bridge/Fluor Enterprises, a JV**OSM Departure Time:** 1730**Contractor:** American Bridge/Fluor Enterprises, a JV**Location:** Jobsite**CWI Name:** See below**CWI Present:** Yes No**Inspected CWI report:** Yes No N/A**Rod Oven in Use:** Yes No N/A**Electrode to specification:** Yes No N/A**Weld Procedures Followed:** Yes No N/A**Qualified Welders:** Yes No N/A**Verified Joint Fit-up:** Yes No N/A**Approved Drawings:** Yes No N/A**Approved WPS:** Yes No N/A**Delayed / Cancelled:** Yes No N/A**Bridge No:** 34-0006**Component:** OBG deck; Piping splices and supports**Summary of Items Observed:**

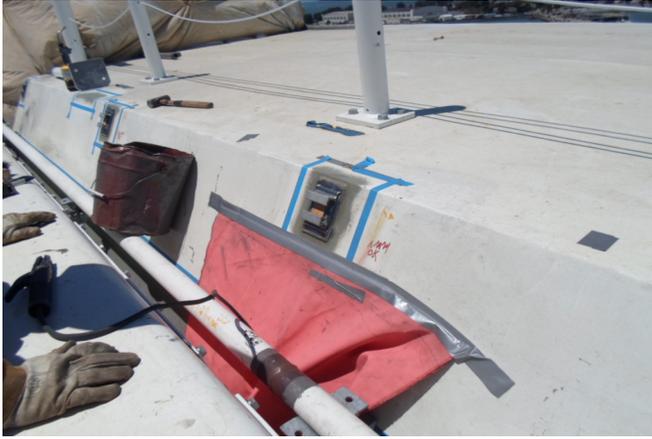
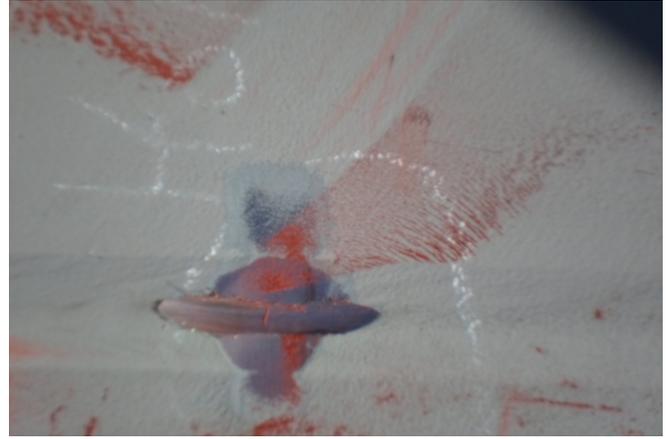
This QAI witnessed the welding of piping support brackets to their mounting plates on the Westbound Cable Shroud for the following locations: PP118(+120), PP118.5, PP119(-420), PP119.5(-620). The welding was performed by F.W. Spencer welder #6520 Barry Mullaney utilizing E7018 electrodes as per the approved WPS #FWS Fillets Murex SFOBB Rev. 1. The AB/F QC Fred Michels was present, monitoring the welding in progress. These welds all appeared to comply with the requirements of the contract documents.

Welding was observed by this QAI of full penetration end-butt splices of 2-1/2" diameter water piping at the following Bikepath locations: PP97, PP99, PP101; PP103, PP105, PP107. The welding was being performed by Tim Esquivel #8348 of F.W. Spencer utilizing E6010 electrodes for the root passes and E7018 electrodes for the fill and cap passes as per the approved WPS 1-12-1. The AB/F QC Fred Michels was present, monitoring the WPS parameters of the welding in progress. These welds all appeared to meet the requirements of the contract documents.

Two other indications were noted; one of which was a gouge indication at location PP14(+1450)/W3(+0) which was flap-wheel sanded to an acceptable profile. The other indication was a 3mm diameter piping porosity at the center of a longitudinal deck splice weld at location PP16(+1230)/W5(-3770). The piping porosity indication was 'flap-wheel' sanded to remove by AB/F personnel visually to a depth of 2.5mm. After the visually detected porosity indication was removed, an MPT inspection was performed by AB/F QC inspector William Sherwood and a transverse linear indication 6mm long became visible directly beneath where the original indication had existed. The AB/F QC directed that the transverse indication be removed, which required additional flap-wheel sanding to a depth of 5.5mm to achieve. The removal to sound metal was verified at that depth with an MPT inspection by AB/F QC. A subsequent repair by welding to full cross-section was performed by AB/F welder #2773 Rick Clayborn utilizing E7018 electrodes as per WPS #1040C, Rev.1. The AB/F QC performed an MPT inspection of this repair area as well as of the other arc strike removal areas. This QAI performed an MPT verification inspection of the above-mentioned repair and arc-strike removal areas. There were no indications noted at this time. See the TL6028 Magnetic Particle Testing report for details.
