**DEPARTMENT OF TRANSPORTATION**

Contract #: 04-0120F4Cty: SF/ALA Rte: 80 PM: 13.2/13.9File #: 1.28**WELDING INSPECTION REPORT****Resident Engineer:** Casey, William**Address:** 333 Burma Road**City:** Oakland, CA 94607**Report No:** WIR-029769**Date Inspected:** 06-Jun-2013**Project Name:** SAS Superstructure**OSM Arrival Time:** 700**Prime Contractor:** American Bridge/Fluor Enterprises, a JV**OSM Departure Time:** 1730**Contractor:** American Bridge/Fluor Enterprises, a JV**Location:** Job Site**CWI Name:** As noted below**CWI Present:** Yes No**Inspected CWI report:** Yes No N/A**Rod Oven in Use:** Yes No N/A**Electrode to specification:** Yes No N/A**Weld Procedures Followed:** Yes No N/A**Qualified Welders:** Yes No N/A**Verified Joint Fit-up:** Yes No N/A**Approved Drawings:** Yes No N/A**Approved WPS:** Yes No N/A**Delayed / Cancelled:** Yes No N/A**Bridge No:** 34-0006**Component:** OBG**Summary of Items Observed:**

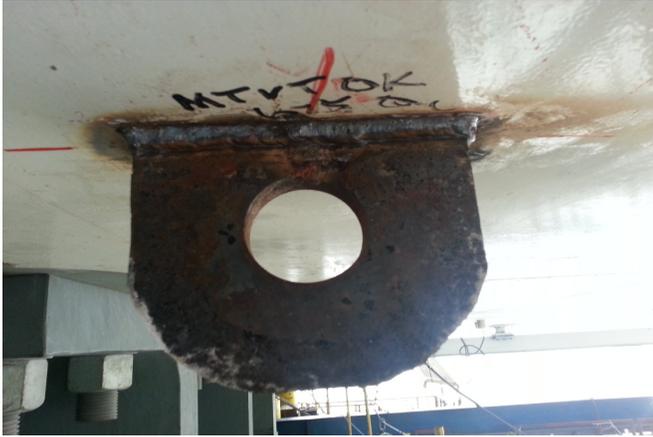
This QA Inspector randomly observed ABF welder Wai Kit Lai #2953 perform the SMAW process in the 4G overhead position on the shear key anchorage lugs at E2. The welder was observed utilizing WPS ABF-D1. 5-F1200A Rev. 2 for fillet welding. The welder was observed preheating the surface area prior to welding and other welding parameters as inspected by the QC Inspector were recorded as 136 amperes and appeared to be in compliance with the WPS noted above. The QA Inspector made subsequent observations throughout the shift to monitor quality and noted that the work was completed on this date and appeared to be in general conformance with the contract documents. RFI-003331R00 was referenced during this observation.
