DEPARTMENT OF TRANSPORTATION

Contract #: 04-0120F4Cty: SF/ALA Rte: 80 PM: 13.2/13.9File #: 1.28**WELDING INSPECTION REPORT****Resident Engineer:** Casey, William**Address:** 333 Burma Road**City:** Oakland, CA 94607**Report No:** WIR-029775**Date Inspected:** 29-Jun-2013**Project Name:** SAS Superstructure**OSM Arrival Time:** 700**Prime Contractor:** American Bridge/Fluor Enterprises, a JV**OSM Departure Time:** 1730**Contractor:** American Bridge/Fluor Enterprises, a JV**Location:** Job Site**CWI Name:** As noted below**CWI Present:** Yes No**Inspected CWI report:** Yes No N/A**Rod Oven in Use:** Yes No N/A**Electrode to specification:** Yes No N/A**Weld Procedures Followed:** Yes No N/A**Qualified Welders:** Yes No N/A**Verified Joint Fit-up:** Yes No N/A**Approved Drawings:** Yes No N/A**Approved WPS:** Yes No N/A**Delayed / Cancelled:** Yes No N/A**Bridge No:** 34-0006**Component:** OBG**Summary of Items Observed:**

WELDING INSPECTION REPORT

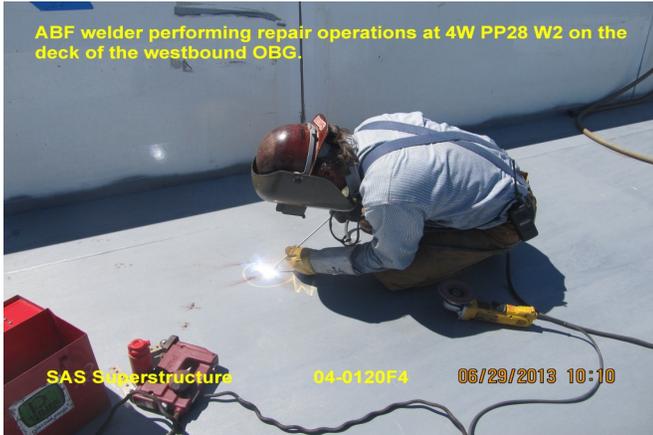
This QA Inspector performed a Deck survey of the surface condition of "A" deck from OBGs 2W PP16 W2 – W4.5 to 4W PP28 W2 – W4.5. This inspection was conducted in conjunction with Smith Emery Quality Control personnel and impact sites as well as arc strikes and any irregularities was measured and recorded for depth and length as well as location. This QA Inspector randomly observed ABF welding personnel perform grinding repairs on "A" deck survey indications at the following locations;

#240 – 2W PP16+0 W4+0

#241 – 2W PP18.5+0 W4.5+0

#242 – 4W PP28+2000mm W2+300mm 60L/30W/6D – RWR pending

The grinding was observed to ensure that minimal material was removed to bring the site to serviceable condition. Upon completion of the grinding Quality Control Inspector Fred Michels was observed performing Magnetic Particle (MPT) Inspection of the sites. QC was observed performing the testing in accordance with AWS D1.5-Section 6.7.6-2002 and ASTM E709. It was noted that no rejectable indications were found and appeared to

comply with the contract specifications.
