Contract #: 04-0120F4Cty: SF/ALA Rte: 80 PM: 13.2/13.9File #: 1.28**WELDING INSPECTION REPORT**

**Report No:** WIR-029787  
**Date Inspected:** 25-Jun-2013

**Project Name:** SAS Superstructure  
**Prime Contractor:** American Bridge/Fluor Enterprises, a JV  
**Contractor:** American Bridge/Fluor Enterprises, a JV

## Crossbeam CB-8

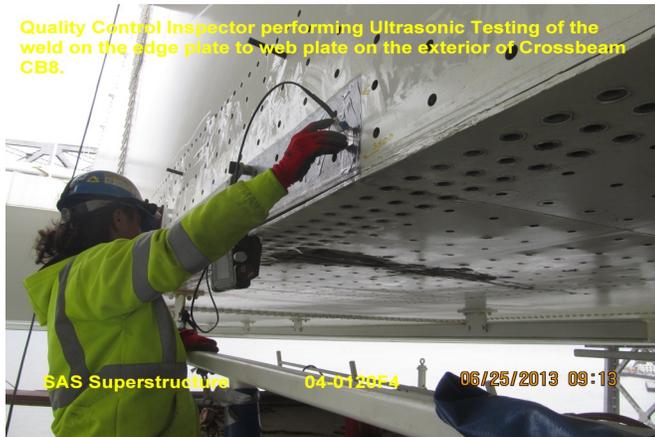
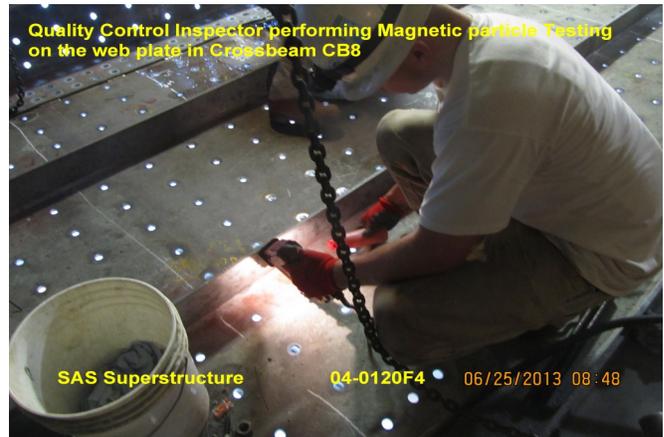
This QA Inspector performed an Ultrasonic (UT) inspection on crossbeam CB8 edge plate (PL14) to web plate (PL14) connection between Y coordinates Y+1700mm to Y+3300mm for verification. This QA Inspector also performed a lamination scan of the web plate between Y coordinates Y+1500mm to Y+3500mm and of the edge plate between Y coordinates Y+2000mm to Y+3000mm and between Y coordinates Y+6000mm to Y+7000mm. The testing of the Complete Joint Penetration (CJP) groove weld was performed as per AWS D1.5~2002, Chapter 6, Part C and Table 6.3, Ultrasonic Acceptance/Reject Criteria. This QA Inspector noted that no rejectable indications were found at the time of testing. The testing of the of the base material was performed as per AWS D1.5~2002, Chapter 3, Section 3.2, Para. 3.2.3.7. At the conclusion of the testing this QA Inspector generated a TL-6027 UT report on this date.

This QA Inspector also performed 100% Magnetic Particle (MPT) testing along the length of the web plate between the following Y coordinates Y+1500mm to Y+3500mm, at the edge plate Y+1200mm to Y+3800mm and Y+5600mm to Y+7300mm. This QA inspector also performed MPT on the stiffener plates identified as 1 and 2 between the Y coordinates 0mm to Y+7500mm. The testing was performed utilizing the yoke method in conformance with ASTM E 709 and the standard of acceptance with AWS D1.5~2002, Chapter 6, Part D. At the conclusion of the testing no rejectable indications were noted. This QA Inspector generated a TL-6028 MT report on this date.

This NDT was performed after straightening operations and before the installation of the retrofit assembly.

The completed work at this location appeared to be in general conformance with the contract specifications and Submittal ABF-SUB-002845R00.
