Contract #: 04-0120F4Cty: SF/ALA Rte: 80 PM: 13.2/13.9File #: 1.28**WELDING INSPECTION REPORT**

**Report No:** WIR-029791  
**Date Inspected:** 03-Jul-2013

**Project Name:** SAS Superstructure  
**Prime Contractor:** American Bridge/Fluor Enterprises, a JV  
**Contractor:** American Bridge/Fluor Enterprises, a JV

<b>CWI Name:</b>	As noted below	<b>CWI Present:</b>	Yes	No
<b>Inspected CWI report:</b>	Yes No N/A	<b>Rod Oven in Use:</b>	Yes No N/A	
<b>Electrode to specification:</b>	Yes No N/A	<b>Weld Procedures Followed:</b>	Yes No N/A	
<b>Qualified Welders:</b>	Yes No N/A	<b>Verified Joint Fit-up:</b>	Yes No N/A	
<b>Approved Drawings:</b>	Yes No N/A	<b>Approved WPS:</b>	Yes No N/A	
		<b>Delayed / Cancelled:</b>	Yes No N/A	
<b>Bridge No:</b>	34-0006	<b>Component:</b>	OBG

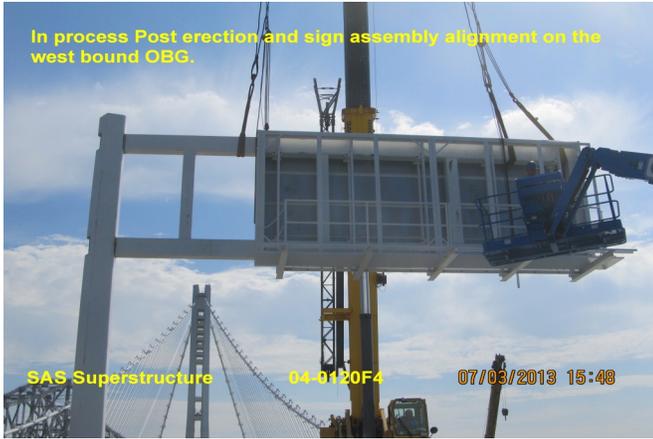
This QA Inspector randomly observed ABF welding personnel erect the west bound OBG sign post. ABF altered the erection in a way that the post was offset to compensate for the weight of the sign assembly. After several attempts to align the sign assembly, survey determined that the post was not offset correctly and upon further inspection it was determined that the bolts on the post were not tightened correctly. Upon completion of the post alignment the sign was installed and ABF welder Wai Kit Lai #2953 performed Flux Core Arc Welding (FCAW) in the 1F (flat) and the 3F (vertical) positions with Eric Sparks #3040 performing Shielded metal Arc Welding (SMAW) in the 4F (overhead) position. Both welders ran 1 pass in each position to maintain sign position but did not disconnect the crane. Inspection was not requested as these initial welds would be removed when alignment operations commence.
