Contract #: 04-0120F4Cty: SF/ALA Rte: 80 PM: 13.2/13.9File #: 1.28**WELDING INSPECTION REPORT**

Report No: WIR-029792
Date Inspected: 04-Jul-2013

Project Name: SAS Superstructure
Prime Contractor: American Bridge/Fluor Enterprises, a JV
Contractor: American Bridge/Fluor Enterprises, a JV

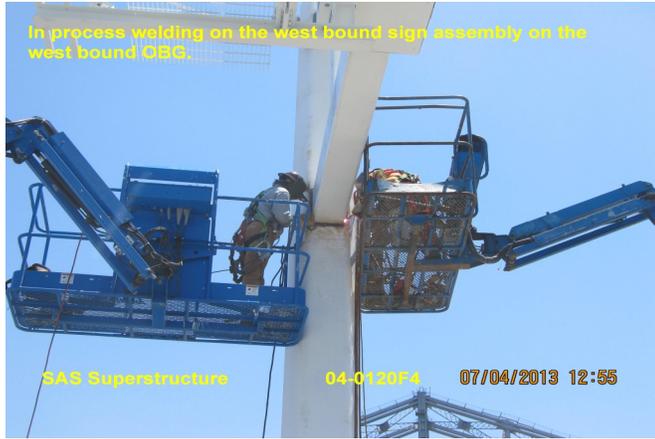
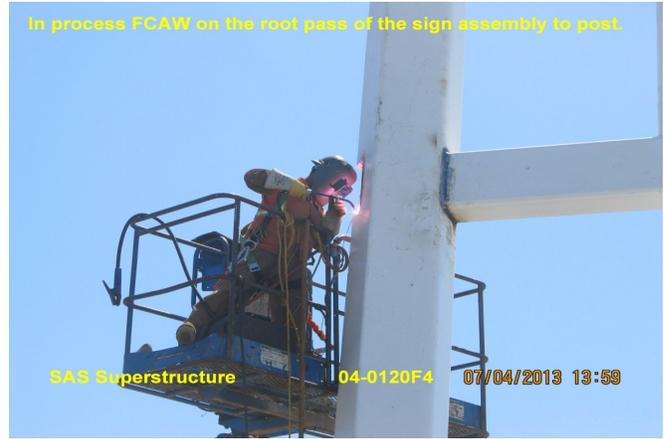
This QA Inspector randomly observed ABF welder Wai Kit Lai #2953 perform Flux Core Arc Welding (FCAW) in the 1F (flat) and the 3F (vertical) positions with Eric Sparks #3040 performing Shielded metal Arc Welding (SMAW) in the 4F (overhead) position as alignment operations commenced. This QA Inspector observed that survey was not available this date and a four (4) foot level was employed to align the sign assembly. It was determined that upon welding the alignment had changed and the welds were Carbon Arc Gouged (CAG) to make adjustments. This QA Inspector noted that several attempts were made to align the sign assembly that when a weld was made the alignment changed. On a subsequent observation the root passes were requested to be inspected by QC. This QA Inspector observed QC perform Magnetic Particle Testing (MPT) on the root passes and noted that no rejectable indications were present. The alignment was verified by ABF and the crane was removed from the assembly. This work is in progress.
