DEPARTMENT OF TRANSPORTATION

Contract #: 04-0120F4Cty: SF/ALA Rte: 80 PM: 13.2/13.9File #: 1.28**WELDING INSPECTION REPORT****Resident Engineer:** Casey, William**Address:** 333 Burma Road**City:** Oakland, CA 94607**Report No:** WIR-029795**Date Inspected:** 11-Jul-2013**Project Name:** SAS Superstructure**OSM Arrival Time:** 700**Prime Contractor:** American Bridge/Fluor Enterprises, a JV**OSM Departure Time:** 1730**Contractor:** American Bridge/Fluor Enterprises, a JV**Location:** Job Site**CWI Name:** As noted below**CWI Present:** Yes No**Inspected CWI report:** Yes No N/A**Rod Oven in Use:** Yes No N/A**Electrode to specification:** Yes No N/A**Weld Procedures Followed:** Yes No N/A**Qualified Welders:** Yes No N/A**Verified Joint Fit-up:** Yes No N/A**Approved Drawings:** Yes No N/A**Approved WPS:** Yes No N/A**Delayed / Cancelled:** Yes No N/A**Bridge No:** 34-0006**Component:** OBG/Shear Key E2**Summary of Items Observed:**

E2 Shear Key Anchorages Plate Beam Assembly

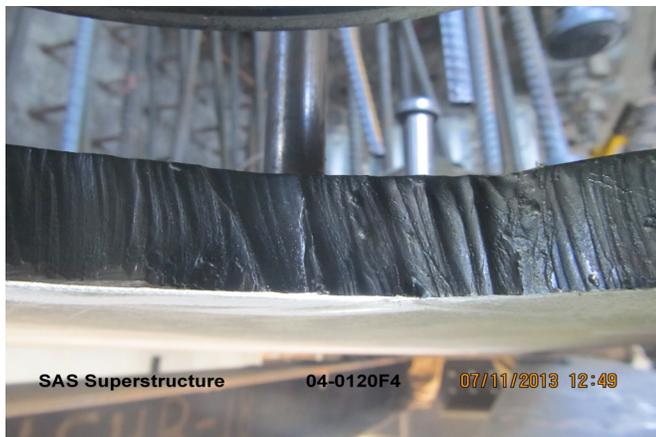
This QA Inspector randomly observed ABF welder Rick Clayborn perform the thermal cutting of the bottom plate (101A) for the placement of the eight (8) studded sleeves (100A/B/C/D) as pertaining to sheet no. 7861-1011BB Delta 1 (Field locate and cut holes per actual locations). Upon completion of the cutting, it was noted that the north plate (of the north shear key) holes were being ground by ABF welding personnel to a smooth surface in accordance with AWS D1.5 Section 3, 3.2.3

(Steel and weld metal may be thermally cut, provided a smooth and regular surface free from cracks and notches is secured, and provided that an accurate profile is secured by the use of a mechanical guide. Freehand thermal cutting shall be done only when approved by the Engineer.)

This QA Inspector visually examined the south plate holes and observed a rough notched surface not in accordance with the code reference above (see photo below). This QA Inspector inquired to ABF Field Engineer Adam Reeves about the surface condition of the holes and he stated that they had been ground and no further work will be done. This QA Inspector informed Quality Control Inspector William Sherwood who informed ABF General Foreman Aaron Kent who stated that it will be taken care of tomorrow.
