Contract #: 04-0120F4Cty: SF/ALA Rte: 80 PM: 13.2/13.9File #: 1.28**WELDING INSPECTION REPORT**

**Report No:** WIR-029816  
**Date Inspected:** 17-Jul-2013

**Project Name:** SAS Superstructure  
**Prime Contractor:** American Bridge/Fluor Enterprises, a JV  
**Contractor:** American Bridge/Fluor Enterprises, a JV

<b>CWI Name:</b>	Jesus Cayabyab	<b>CWI Present:</b>	Yes	No
<b>Inspected CWI report:</b>	Yes No N/A	<b>Rod Oven in Use:</b>	Yes	No N/A
<b>Electrode to specification:</b>	Yes No N/A	<b>Weld Procedures Followed:</b>	Yes	No N/A
<b>Qualified Welders:</b>	Yes No N/A	<b>Verified Joint Fit-up:</b>	Yes	No N/A
<b>Approved Drawings:</b>	Yes No N/A	<b>Approved WPS:</b>	Yes	No N/A
		<b>Delayed / Cancelled:</b>	Yes	No N/A
<b>Bridge No:</b>	34-0006	<b>Component:</b>	SAS Tower

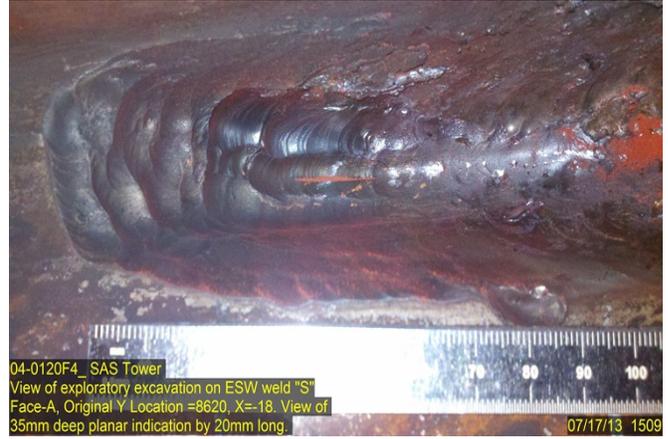
ESW "S", Face A

Indication first discovered at Y= (Original) 8620mm, X= -18mm

Indication visible at: 27mm deep, 35mm long

Indication visible at: 35mm deep, 20mm long

Indication removed at: 43 mm deep

Final excavation Y=8580mm~8730mm, Length=150mm, Width=50mm & Depth=43mm.

ABF QC Office Engineer Chris Chew stated ABF have approval to weld the ESW PC excavation at this location per RWR 201307-003. The QA/QC Inspectors did verify that the planar type indication was removed on this shift.
