DEPARTMENT OF TRANSPORTATION

Contract #: 04-0120F4Cty: SF/ALA Rte: 80 PM: 13.2/13.9File #: 1.28**WELDING INSPECTION REPORT****Resident Engineer:** Casey, William**Address:** 333 Burma Road**City:** Oakland, CA 94607**Report No:** WIR-029817**Date Inspected:** 13-Jul-2013**Project Name:** SAS Superstructure**OSM Arrival Time:** 700**Prime Contractor:** American Bridge/Fluor Enterprises, a JV**OSM Departure Time:** 1530**Contractor:** American Bridge/Fluor Enterprises, a JV**Location:** Job Site**CWI Name:** Fred Michels**CWI Present:** Yes No**Inspected CWI report:** Yes No N/A**Rod Oven in Use:** Yes No N/A**Electrode to specification:** Yes No N/A**Weld Procedures Followed:** Yes No N/A**Qualified Welders:** Yes No N/A**Verified Joint Fit-up:** Yes No N/A**Approved Drawings:** Yes No N/A**Approved WPS:** Yes No N/A**Delayed / Cancelled:** Yes No N/A**Bridge No:** 34-0006**Component:** SAS OBG**Summary of Items Observed:**

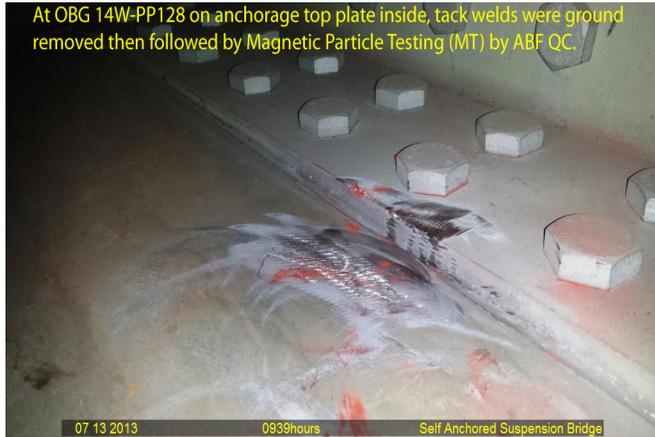
At OBG 14W-PP128-W2/W3 inside top anchorage top plate, this QA randomly observed ABF personnel perform removal of tack welds between the 203mm x 203mm x 13mm angle to anchorage top plate which was designated as Seismic Performance Critical Material (SPCM). ABF personnel were noted grinding off remove the tack weld then followed by Magnetic Particle Testing (MT) by ABF QC Brian Connolly. All the eight top plate anchorage access holes were entered by ABF personnel and removed 2 to 4 pieces of tack welds on each hole. Inside the access holes where the angle and top anchorage plate were installed, ABF personnel and ABF QC perform inspection to make sure there was no tack welds left between the angle and anchorage bolted connections. This was randomly verified by this QA. This task was done to clear punch list item #3529 that was originated from ZPMC China.
