Contract #: 04-0120F4Cty: SF/ALA Rte: 80 PM: 13.2/13.9File #: 1.28**WELDING INSPECTION REPORT**

Report No: WIR-029841
Date Inspected: 20-Jul-2013

Project Name: SAS Superstructure **OSM Arrival Time:** 700
Prime Contractor: American Bridge/Fluor Enterprises, a JV **OSM Departure Time:** 1530
Contractor: American Bridge/Fluor Enterprises, a JV **Location:** Job Site

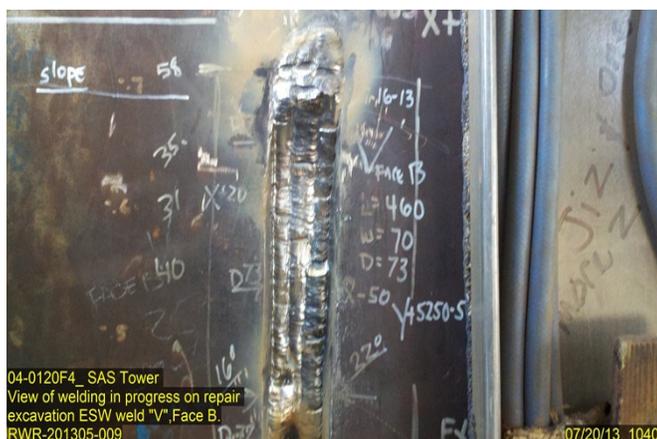
ESW W-041, Location “V”-Face B

The QA Inspector observed, at random intervals, ABF/JV welder Mike Jimenez (WID-4671) performing weld repairs of the repair excavation on Electroslag Weld (ESW) “V”, at face B locations noted as:

The welder was observed preheating the weld to over 300° Fahrenheit prior to welding using the Miller ProHeat 35 with heat induction blankets. The welder was using 4.0mm diameter electrode (E7018-MH4-R) per ABF Welding Procedure Specification (WPS) ABF-WPS-D15-1000-Repair Rev.3 for Shield Metal Arc Welding (SMAW). The welding parameters were verified by QC Inspector Bernie Docena throughout the day and appeared to be in compliance with the WPS noted above.
