Contract #: 04-0120F4Cty: SF/ALA Rte: 80 PM: 13.2/13.9File #: 1.28**WELDING INSPECTION REPORT**

Report No: WIR-029848
Date Inspected: 22-Jul-2013

Project Name: SAS Superstructure **OSM Arrival Time:** 700
Prime Contractor: American Bridge/Fluor Enterprises, a JV **OSM Departure Time:** 1730
Contractor: American Bridge/Fluor Enterprises, a JV **Location:** Job Site

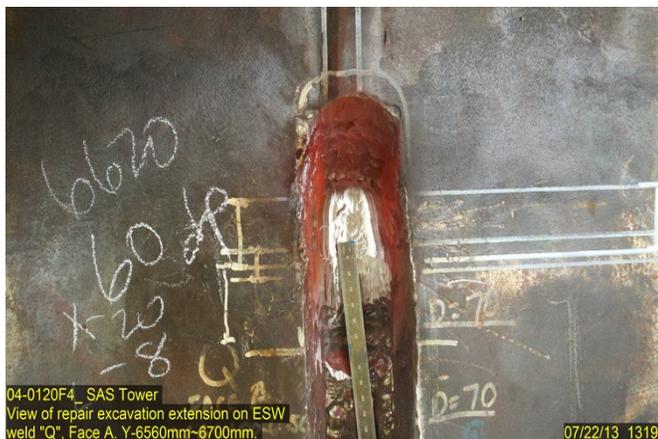
The QA Inspector observed at random intervals, ABF/JV welder Don Plumb (WID-0891) performing carbon arc air gouging of ESW "Q" Face A, to verify indications observed during Ultrasonic Testing. ABF Quality Control (QC) Inspector Jesse Cayabyab was observed monitoring the work and informed the QA Inspector that all indications in these Y locations will be removed and repaired for ring beam installation. Locations of the repair excavation and indications observed are as follows:

60mm depth of excavation –8mm long indication @ Y=-6620, X= -20.

62mm depth of excavation- Indication removed.

During excavation and after grinding to bright metal Mr. Cayabyab was observed performing MT testing at various intervals of the excavation to ensure the discontinuities were removed. The QA Inspector also performed MT inspection of the excavation and did not observe any weld defects. The QC Inspector stated that this work is a continuation from the previous excavation to remove suspected indications. See TL-6028 for information on items inspected on this date.
