**DEPARTMENT OF TRANSPORTATION**

Contract #: 04-0120F4Cty: SF/ALA Rte: 80 PM: 13.2/13.9File #: 1.28**WELDING INSPECTION REPORT****Resident Engineer:** Casey, William**Address:** 333 Burma Road**City:** Oakland, CA 94607**Report No:** WIR-029859**Date Inspected:** 28-May-2013**Project Name:** SAS Superstructure**OSM Arrival Time:** 700**Prime Contractor:** American Bridge/Fluor Enterprises, a JV**OSM Departure Time:** 1530**Contractor:** USA Hoist, Crest Hill, IL.**Location:** USA Hoist, 1000 Sak Drive

**Bridge No:** 34-0006**Component:** Tower Elevator guide masts & mounting brackets**Summary of Items Observed:**

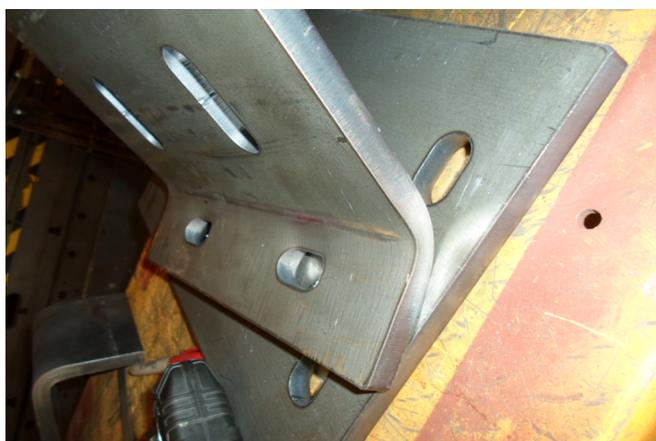
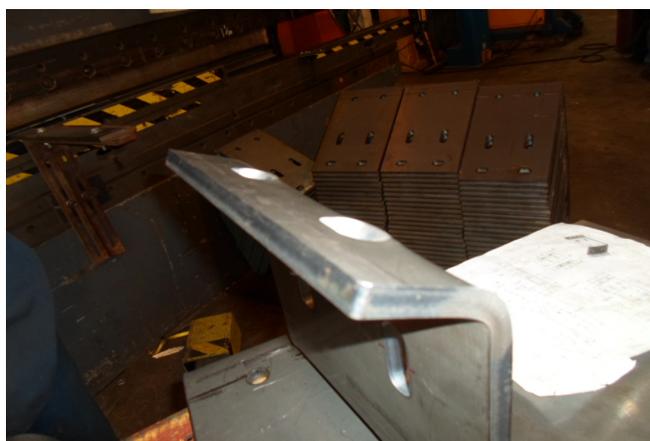
This QAI also revisited USA Hoist's local vendor, General Machine & Tool Co., Joliet, IL., where the bending operations for the Tower Elevator tie-in attachment bracket plates were being performed. It was noted by this QAI after arriving inside the shop, that there was concern among their staff that member #18 (142 pieces total) of drawing #914204 may not be able to be formed acceptably per the design. This concern was due to the (too) close design proximity of bolt holes to the 30 degree and 60 degree respective bends at opposite ends of each plate. A single test sample of the 1/2" plate had been bent per that design drawing to test it's feasibility for production. The resulting plate exhibited distortion of the shape and width of the slotted holes at the side of the holes which were adjacent the bend radii. Most notable of the sample plate's appearance were the depressed areas (below the plate's surface) adjacent the inside radius of the bends, and conversely the protruding areas adjacent the outside radius of the bends. When this QAI was asked by a General Machine representative how they should proceed, the response was a recommendation that USA Hoist's Design Engineer should be consulted as soon as possible for direction.
