Contract #: 04-0120F4Cty: SF/ALA Rte: 80 PM: 13.2/13.9File #: 1.28**WELDING INSPECTION REPORT**

Report No: WIR-029870
Date Inspected: 25-Jul-2013

Project Name: SAS Superstructure **OSM Arrival Time:** 700
Prime Contractor: American Bridge/Fluor Enterprises, a JV **OSM Departure Time:** 1730
Contractor: American Bridge/Fluor Enterprises, a JV **Location:** Job Site

CWI Name:	Jesus Cayabyab, Bernie Docena	CWI Present:	Yes	No
Inspected CWI report:	Yes No N/A	Rod Oven in Use:	Yes	No N/A
Electrode to specification:	Yes No N/A	Weld Procedures Followed:	Yes	No N/A
Qualified Welders:	Yes No N/A	Verified Joint Fit-up:	Yes	No N/A
Approved Drawings:	Yes No N/A	Approved WPS:	Yes	No N/A
		Delayed / Cancelled:	Yes	No N/A
Bridge No:	34-0006	Component:	SAS Tower

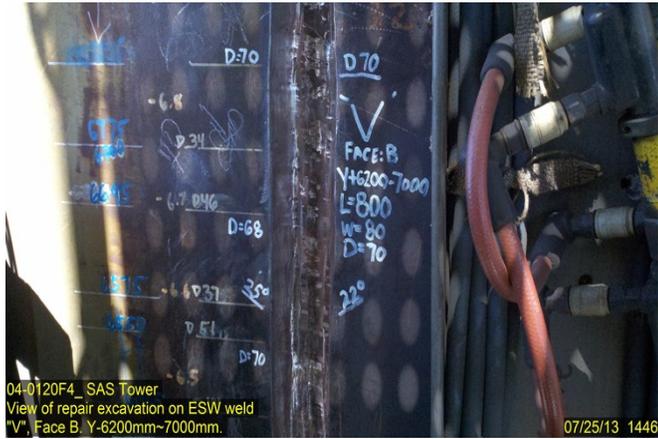
QA observed at random intervals, ABF/JV welder Mike Jimenez (WID-4671) performing carbon arc air gouging of ESW welds for defect removal on ESW weld designated as "V". Location of excavation was noted as:

Excavation Y= 6200mm~7000mm

After excavation and grinding to bright metal ABF Quality Control (QC) Inspector Bernie Docena was observed performing MT testing of the excavation to ensure all discontinuities were removed prior to welding. The QA Inspector also performed MT inspection of the excavation and did not observe any weld defects. See TL-6028 for
