**DEPARTMENT OF TRANSPORTATION**

Contract #: 04-0120F4Cty: SF/ALA Rte: 80 PM: 13.2/13.9File #: 1.28**WELDING INSPECTION REPORT**

**Report No:** WIR-029872  
**Date Inspected:** 27-Jul-2013

**Project Name:** SAS Superstructure **OSM Arrival Time:** 700  
**Prime Contractor:** American Bridge/Fluor Enterprises, a JV **OSM Departure Time:** 1530  
**Contractor:** American Bridge/Fluor Enterprises, a JV **Location:** Job Site

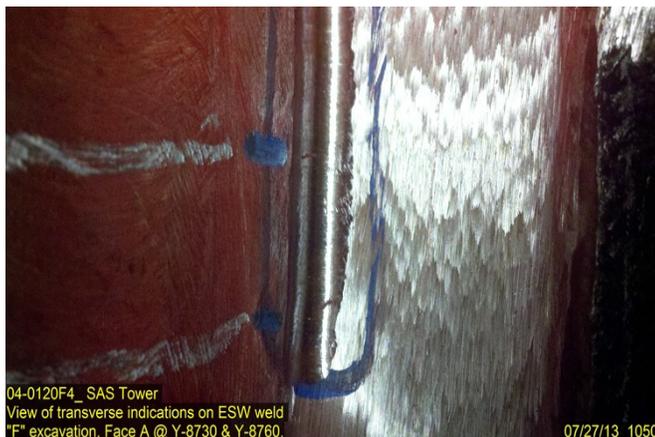
ESW E-045,"F"-Face A:

The QA Inspector was later present to observe ABF welder Simon Ma performing exploratory excavation of ESW "F" Face A @ Y-8790mm, 8960mm to verify indications observed during Ultrasonic Testing pulse/echo & pitch/catch. Mr. Ma was performing grinding on the excavation. ABF QC Inspector Jesse Cayayab stated that Mr. Ma will excavate every 2mm deep and allow QC/QA to inspect the excavation. Location of the repair is as follows:

Weld excavated at 10mm- Transverse indication @Y-8730

Weld excavated at 12mm- Transverse indication @Y-8730, Transverse indication @Y-8760

Weld excavated at 14mm- Transverse indication @Y-8730, Transverse indication @Y-8760

Excavation Length Y=8680mm~9090mm (Excavation work in progress to be continued on the next work shift)

After grinding to bright metal the QC Inspector performed MT testing of the excavation to inspect for weld discontinuities at each hold point. Please note that the toe crack indication on the surface of the ESW weld @ 8520mm~8700mm still remains. The information regarding the toe crack was passed along to ABF and CT METS representatives for further review. See TL-6028 for additional details on items inspected.
