DEPARTMENT OF TRANSPORTATION

Contract #: 04-0120F4Cty: SF/ALA Rte: 80 PM: 13.2/13.9File #: 1.28**WELDING INSPECTION REPORT****Resident Engineer:** Casey, William**Address:** 333 Burma Road**City:** Oakland, CA 94607**Report No:** WIR-029875**Date Inspected:** 18-Jul-2013**Project Name:** SAS Superstructure**OSM Arrival Time:** 700**Prime Contractor:** American Bridge/Fluor Enterprises, a JV**OSM Departure Time:** 1200**Contractor:** American Bridge/Fluor Enterprises, a JV**Location:** Job Site

Bridge No: 34-0006**Summary of Items Observed:**

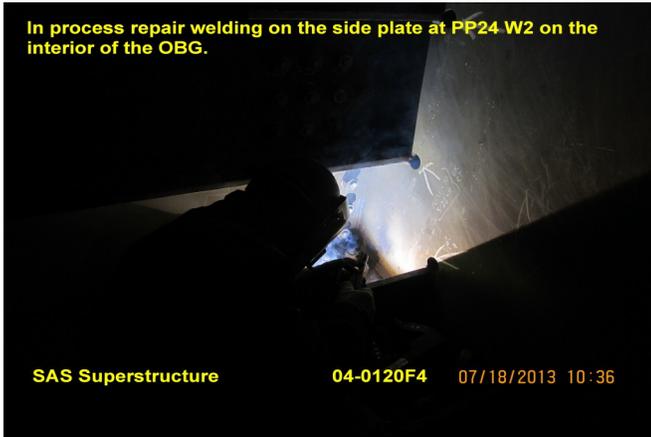
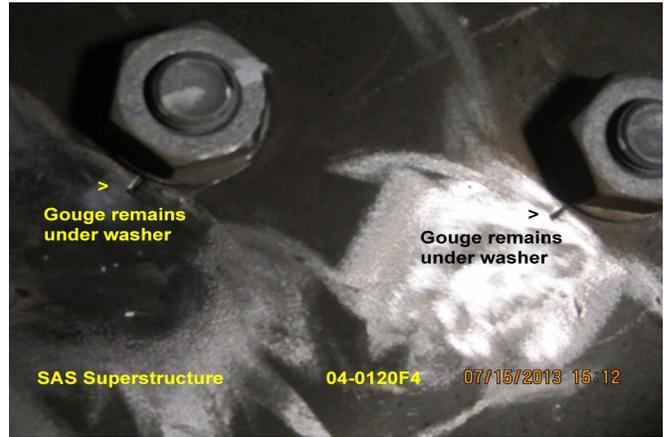
This QA Inspector randomly observed ABF personnel remove the High Strength Bolt from the side plate at PP 24 W2 in order for ABF welder Rick Clayborn #2773 to perform welding repair procedures on the gouges in the plate that extended under the bolt washers. This QA Inspector randomly observed the welder perform the Shielded Metal Arc Welding (SMAW) process on surface. The welder was observed utilizing WPS ABF-D1.5-1003-Repair for Fillet welding. The welder was observed preheating the surface area prior to welding and other welding parameters as inspected by the QC Inspector were recorded as 136 amperes and appeared to be in compliance with the WPS noted above. Upon completion of the welding and the area return to ambient temperature, this QA Inspector observed QC Inspector Bernard Docena perform Ultrasonic Testing (UT) on the site to verify sound metal. QC reported that no indications were present and the bolt was reinstalled and torqued to specifications in accordance with the repair procedure. The second bolt was removed and the process was repeated. This QA Inspector made random observations throughout the shift to monitor quality and noted that the work was in progress and appeared to be in general conformance with the contract specifications.
