DEPARTMENT OF TRANSPORTATION

Contract #: 04-0120F4Cty: SF/ALA Rte: 80 PM: 13.2/13.9File #: 1.28**WELDING INSPECTION REPORT****Resident Engineer:** Casey, William**Address:** 333 Burma Road**City:** Oakland, CA 94607**Report No:** WIR-029879**Date Inspected:** 27-Jul-2013**Project Name:** SAS Superstructure**OSM Arrival Time:** 700**Prime Contractor:** American Bridge/Fluor Enterprises, a JV**OSM Departure Time:** 1530**Contractor:** American Bridge/Fluor Enterprises, a JV**Location:** Job Site**CWI Name:** Salvador Merino**CWI Present:** Yes No**Inspected CWI report:** Yes No N/A**Rod Oven in Use:** Yes No N/A**Electrode to specification:** Yes No N/A**Weld Procedures Followed:** Yes No N/A**Qualified Welders:** Yes No N/A**Verified Joint Fit-up:** Yes No N/A**Approved Drawings:** Yes No N/A**Approved WPS:** Yes No N/A**Delayed / Cancelled:** Yes No N/A**Bridge No:** 34-0006**Component:** SAS OBG**Summary of Items Observed:**

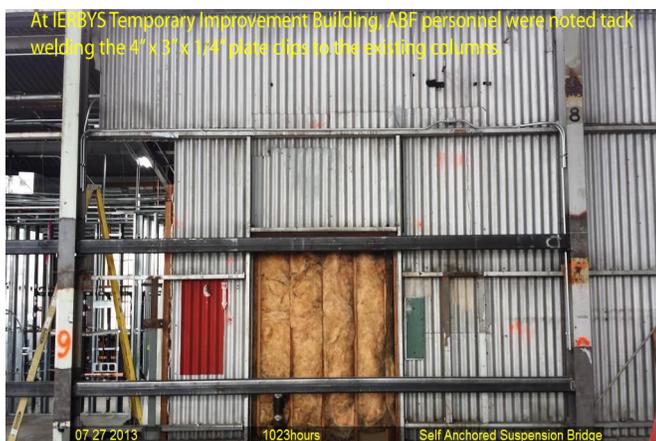
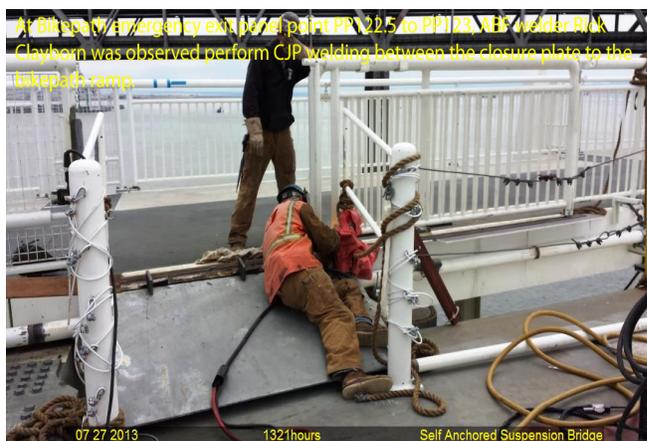
At 210 Burma Road, Oakland, CA, where IERBYS Temporary Improvement Building is being renovated, ABF personnel were observed continuing to perform layout on the 4" x 3" x 1/4" thick clip plate to the existing building column. The welder was noted tack welding the 4" x 3" x 1/4" clip to the existing column using self shielded Flux Cored Arc Welding (FCAW-S) with 0.072" diameter E71T-8 wire electrode implementing Caltrans procedure ABF-WPS-D11-F2200. The welder was noted tack welding the clip plates to the existing W-column at columns 8 and 9, columns 9 and 10, and columns 10 and 11. During the shift, ABF personnel were only able to tack weld the clips to the existing columns. There was no fillet welding performed on the clips to the existing columns.
