DEPARTMENT OF TRANSPORTATION

Contract #: 04-0120F4Cty: SF/ALA Rte: 80 PM: 13.2/13.9File #: 1.28**WELDING INSPECTION REPORT**

Report No: WIR-029894
Date Inspected: 01-Aug-2013

Project Name: SAS Superstructure **OSM Arrival Time:** 700
Prime Contractor: American Bridge/Fluor Enterprises, a JV **OSM Departure Time:** 1730
Contractor: American Bridge/Fluor Enterprises, a JV **Location:** Job Site

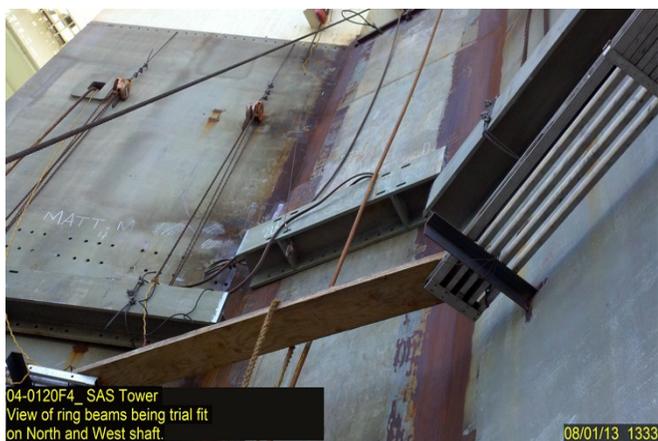
The QA Inspector was informed by ABF QC Inspector Bernie Docena that ABF Ironworker crew are installing and trail fitting ring beams at the exterior of the west and north shaft of the Tower. Mr. Docena stated that the beams are having access weld holes cut and bevels prepped at the ends where the beams will splice. The rings beams are being positioned where they will be installed and are having bolt access holes reamed and temporary bolts installed. The QC Inspector stated that ABF ironworker crew production plan to start SMAW welding ring beam exterior corners the week of 8-05-13.
