DEPARTMENT OF TRANSPORTATION

Contract #: 04-0120F4Cty: SF/ALA Rte: 80 PM: 13.2/13.9File #: 1.28**WELDING INSPECTION REPORT****Resident Engineer:** Casey, William**Address:** 333 Burma Road**City:** Oakland, CA 94607**Report No:** WIR-029902**Date Inspected:** 13-Aug-2013**Project Name:** SAS Superstructure**OSM Arrival Time:** 700**Prime Contractor:** American Bridge/Fluor Enterprises, a JV**OSM Departure Time:** 1730**Contractor:** American Bridge/Fluor Enterprises, a JV**Location:** Job Site**CWI Name:** Bernie Docena, Jesse Cayabyab**CWI Present:** Yes No**Inspected CWI report:** Yes No N/A**Rod Oven in Use:** Yes No N/A**Electrode to specification:** Yes No N/A**Weld Procedures Followed:** Yes No N/A**Qualified Welders:** Yes No N/A**Verified Joint Fit-up:** Yes No N/A**Approved Drawings:** Yes No N/A**Approved WPS:** Yes No N/A**Delayed / Cancelled:** Yes No N/A**Bridge No:** 34-0006**Component:** SAS Tower**Summary of Items Observed:**

WELDING INSPECTION REPORT

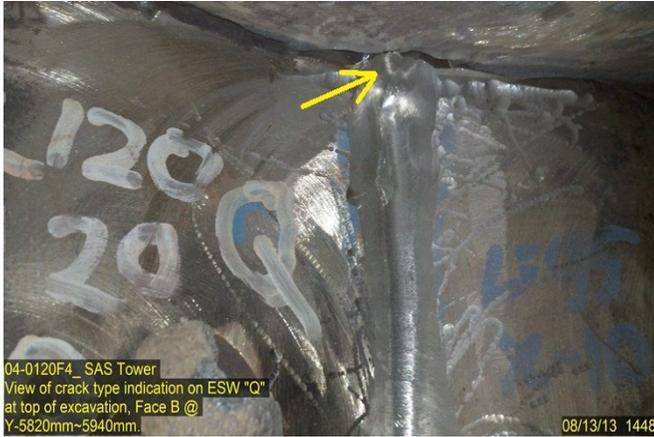
The QA Inspector was informed by ABF QC Inspector Bernie Docena that during repair excavation on Electroslag Weld (ESW) "Q", at face A, QC had discovered a crack in the excavation under the diaphragm. The QC Inspector stated that that the indication was verified with UT and appears to run into the diaphragm an additional 20mm.

This repair was previously performed on (8/09/13) and is currently on hold until ABF propose a corrective procedure to remove and repair the location. Y locations was noted as:

Y= 5820mm~5940mm

L= 120mm

W= 20mm

D= 10mm

ABF Field Engineer Eric Blue stated that ABF may possibly propose to cut a cope hole in the diaphragm to aid in removing and repairing the defect and gain access for the repair. No other work will be performed at this location until CT METS are allowed time to review and approve the repair procedure.
