DEPARTMENT OF TRANSPORTATION

Contract #: 04-0120F4Cty: SF/ALA Rte: 80 PM: 13.2/13.9File #: 99.28**WELDING INSPECTION REPORT****Resident Engineer:** Casey, William**Address:** 333 Burma Road**City:** Oakland, CA 94607**Report No:** WIR-029903**Date Inspected:** 08-Aug-2013**Project Name:** SAS Superstructure**OSM Arrival Time:** 700**Prime Contractor:** American Bridge/Fluor Enterprises, a JV**OSM Departure Time:** 1730**Contractor:** American Bridge/Fluor Enterprises, a JV**Location:** Job Site**CWI Name:** Anthony Sherwood**CWI Present:** Yes No**Inspected CWI report:** Yes No N/A**Rod Oven in Use:** Yes No N/A**Electrode to specification:** Yes No N/A**Weld Procedures Followed:** Yes No N/A**Qualified Welders:** Yes No N/A**Verified Joint Fit-up:** Yes No N/A**Approved Drawings:** Yes No N/A**Approved WPS:** Yes No N/A**Delayed / Cancelled:** Yes No N/A**Bridge No:** 34-0006**Component:** Tower ESW Welds**Summary of Items Observed:**

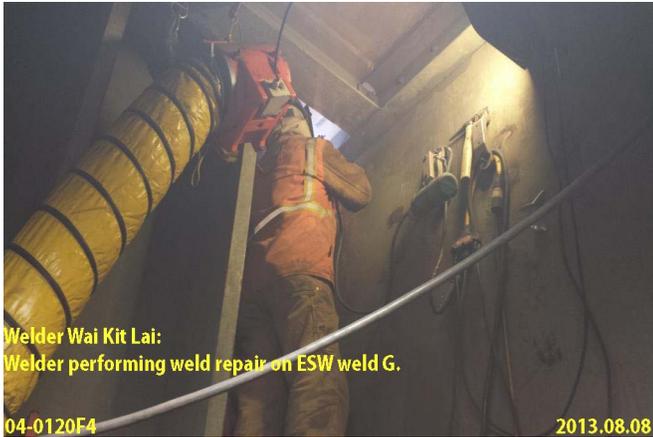
The welder was observed performing weld repairs on Ultrasonic Testing rejected indications on weld ESW G at Face B between Y locations 9090 and 9500 as per Request Weld Repair (RWR) 201307-005. The indication was excavated to 310 x 60 x 30 deep. The welder was observed preheating the weld to 350 degrees Fahrenheit prior to welding using the Miller ProHeat 35 with heat induction blankets. The welder utilized the Welding Procedure Specification (WPS) ABF-WPS-D15-1000-Repair Rev.3 for Shield Metal Arc Welding (SMAW). The welding parameters were verified by QC Inspector Anthony Sherwood throughout the day and they appeared to be in compliance with the WPS noted above.
