DEPARTMENT OF TRANSPORTATION

Contract #: 04-0120F4Cty: SF/ALA Rte: 80 PM: 13.2/13.9File #: 99.28**WELDING INSPECTION REPORT****Resident Engineer:** Casey, William**Address:** 333 Burma Road**City:** Oakland, CA 94607**Report No:** WIR-029904**Date Inspected:** 09-Aug-2013**Project Name:** SAS Superstructure**OSM Arrival Time:** 700**Prime Contractor:** American Bridge/Fluor Enterprises, a JV**OSM Departure Time:** 1730**Contractor:** American Bridge/Fluor Enterprises, a JV**Location:** Job Site**CWI Name:** Bernard Docena**CWI Present:** Yes No**Inspected CWI report:** Yes No N/A**Rod Oven in Use:** Yes No N/A**Electrode to specification:** Yes No N/A**Weld Procedures Followed:** Yes No N/A**Qualified Welders:** Yes No N/A**Verified Joint Fit-up:** Yes No N/A**Approved Drawings:** Yes No N/A**Approved WPS:** Yes No N/A**Delayed / Cancelled:** Yes No N/A**Bridge No:** 34-0006**Component:** Tower ESW Welds**Summary of Items Observed:**

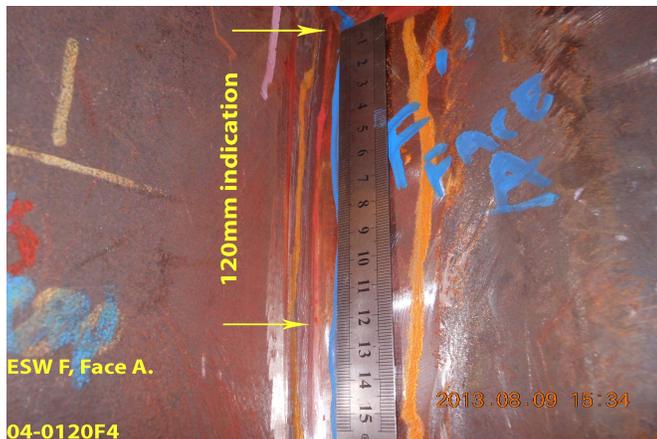
The welder was observed performing weld repairs by grinding on Magnetic Particle Testing (MPT) rejected indication on weld ESW F, Face A at Y locations 8530 and 8670. Weld toe indication was ground at 120 x 28 x 10 deep. Weld repair to commence on the next shift after approval from the Engineer. QC Inspector Bernard Docena was observed performing Magnetic Particle Testing (MPT) to verify removal of indication by the welder with the grinder.
