DEPARTMENT OF TRANSPORTATION

Contract #: 04-0120F4Cty: SF/ALA Rte: 80 PM: 13.2/13.9File #: 01.28**WELDING INSPECTION REPORT****Resident Engineer:** Casey, William**Address:** 333 Burma Road**City:** Oakland, CA 94607**Report No:** WIR-029906**Date Inspected:** 12-Aug-2013**Project Name:** SAS Superstructure**OSM Arrival Time:** 700**Prime Contractor:** American Bridge/Fluor Enterprises, a JV**OSM Departure Time:** 1730**Contractor:** American Bridge/Fluor Enterprises, a JV**Location:** Job Site

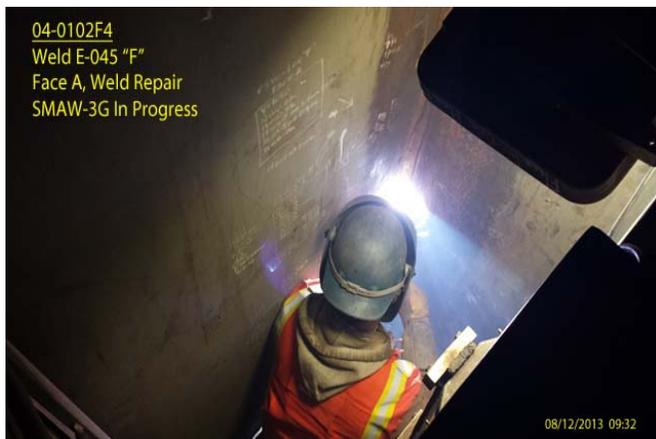
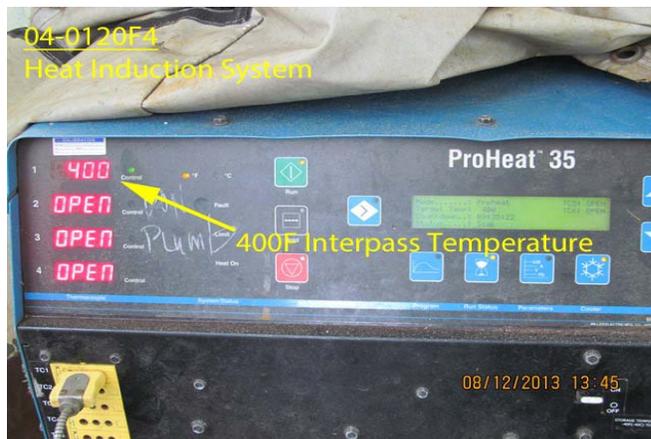
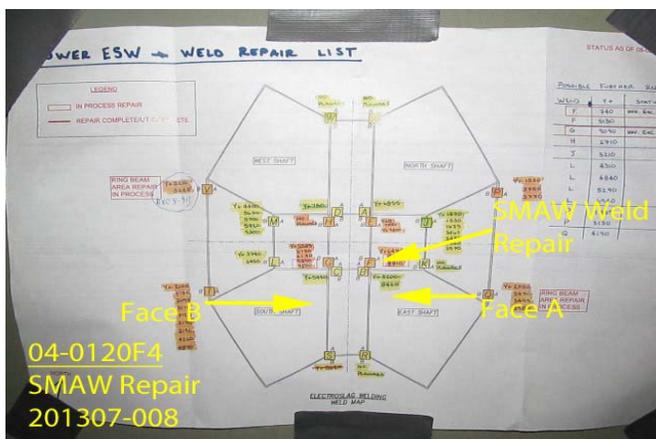
The QAI periodically observed ABF welding personnel Donald Plum and Wai Kit Lai utilizing the Shielded Metal Arc Welding (SMAW) in the vertical (3G) position with Atom Arc E7018-1 H4R, 1/8" diameter electrode to weld excavation for a weld repair. The welding is taking place in the inner chamber between the north & east shaft at joint F, weld #E-045 on Face A side for a repair designated as 201307-008. QAI reviewed a copy of ABF repair procedure and noted excavation dimensions as 190mm length, 55mm width, 40mm depth, y dimension of 650mm to 840mm. The QAI observed the interpass temperature was maintained at approximately 400 degrees Fahrenheit with electric heating coil blankets through a heat induction system. As welding continued the QAI periodically verified welding amperage at approximately 128 amperes. Several verifications of this reading were made throughout the day with similar readings. The Welding Procedure Specification (WPS) designated for this repair was identified as ABF-WPS-D1.5-1000Repair, Rev.3.

The welding & workmanship observed on this date appeared to be in general compliance with the contract specifications. The following pictures below detail some of the observations made on this date.
