DEPARTMENT OF TRANSPORTATION

Contract #: 04-0120F4Cty: SF/ALA Rte: 80 PM: 13.2/13.9File #: 1.28**WELDING INSPECTION REPORT****Resident Engineer:** Casey, William**Address:** 333 Burma Road**City:** Oakland, CA 94607**Report No:** WIR-029912**Date Inspected:** 06-Aug-2013**Project Name:** SAS Superstructure**OSM Arrival Time:** 700**Prime Contractor:** American Bridge/Fluor Enterprises, a JV**OSM Departure Time:** 1730**Contractor:** American Bridge/Fluor Enterprises, a JV**Location:** Job Site

WELDING INSPECTION REPORT

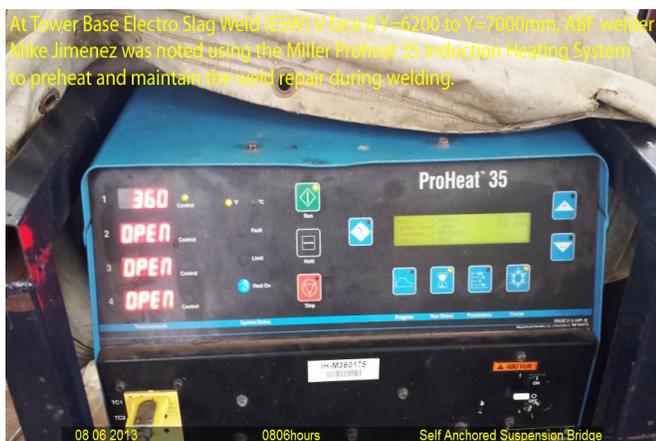
At the Tower Base Electro Slag Welding (ESW) V joint W-043 location Y=6200mm to Y=7000mm, QA randomly observed the ABF welder Mike Jimenez continuing to perform 3G SMAW welding repair on the Ultrasonic Testing (UT) detected reject on the vertical weld of the ESW. The repair excavation is being welder per the approved Request for Weld Repair (RWR) #201208-040 thru #201208-043. The welder was observed welding in the 3G (vertical) position utilizing Shielded Metal Arc Welding (SMAW) with 5/32" diameter E7018H4R electrode implementing the welding procedure ABF-WPS-D15-1000-R03 Repair. The repair excavation and the adjacent base metal was preheated to more than 350°F using Miller Proheat 35 Induction Heating System prior/during welding. During the shift, ABF QC Jesse Cayabyab was noted monitoring the workmanship and welding parameters of the welder. The measured welding parameter were recorded as 180 amperes on a 5/32" diameter E7018H4R electrode. At the end of the shift, 3G repair welding was completed and the welder performed the Post Weld Heat Treatment (PWHT) of 350 degrees Fahrenheit with holding time of three hours.

At Tower Base Electro Slag Weld (ESW) V face B Y=6200 to Y=7000mm, ABF welder Mike Jimenez was noted using the Miller Proheat 35 Induction Heating System to preheat and maintain the weld repair during welding.

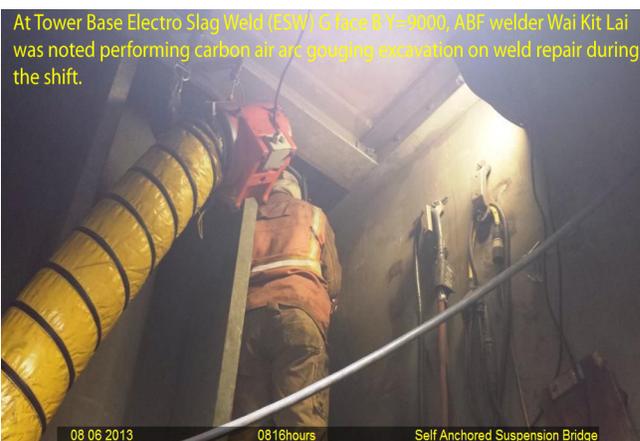
At Tower Base Electro Slag Weld (ESW) ‘G’ weld joint #S-045 face B, ABF welder Wai Kit Lai was observed continuing to perform excavation on welded ESW at location Y=9400 due to UT detected defects. The ABF personnel used carbon air arc gouging to excavate the defects. This excavation was performed per Caltrans approved Request for Weld Repair RWR#201307-005. ABF QC Jesse Cayabyab was noted on site monitoring the welder during the excavation. During the shift, excavation of the defect was completed with measured dimensions of 310mm long x 60mm wide x 30mm deep. The excavation was VT/MT tested by ABF QC Jesse Cayabyab with no relevant indications noted.

At Tower Base Electro Slag Weld (ESW) G face B Y=9000, ABF welder Wai Kit Lai was noted performing carbon air arc gouging excavation on weld repair during the shift.
