DEPARTMENT OF TRANSPORTATION

Quality Assurance and Source Inspection

Contract #: 04-0120F4Cty: SF/ALA Rte: 80 PM: 13.2/13.9File #: 1.28**WELDING INSPECTION REPORT****Resident Engineer:** Casey, William**Address:** 333 Burma Road**City:** Oakland, CA 94607**Report No:** WIR-029916**Date Inspected:** 12-Aug-2013**Project Name:** SAS Superstructure**OSM Arrival Time:** 700**Prime Contractor:** American Bridge/Fluor Enterprises, a JV**OSM Departure Time:** 1730**Contractor:** American Bridge/Fluor Enterprises, a JV**Location:** Job Site

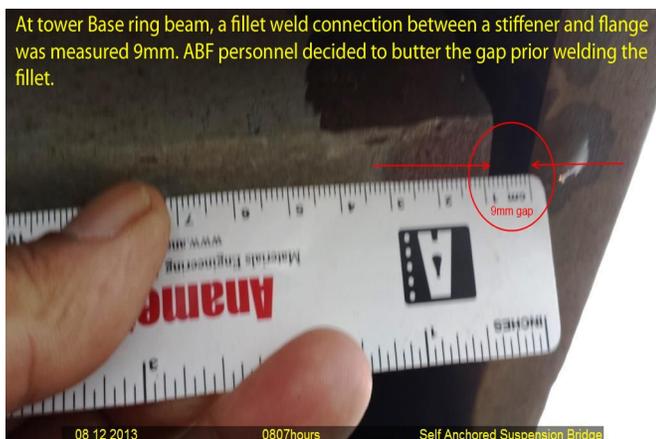
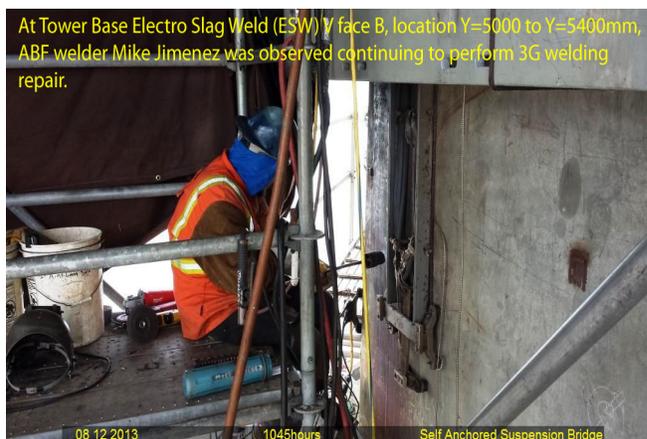
At the northeast corner of the tower, ABF personnel were noted fitting the corner joint connection of the tower skirt ring beam. During the fit up, this QA noted that there was a considerable gap at the 9mm elevation between the flange to the stiffener that requires fillet welding. This information was passed on to ABF QC William Sherwood who also informed the welding foreman Richard Chouinard about the gap. Due to this measured gap, ABF personnel unbolted one of the ring beams and performed buttering on the stiffener plate where it connects to the flange.
