DEPARTMENT OF TRANSPORTATION

Quality Assurance and Source Inspection

Contract #: 04-0120F4Cty: SF/ALA Rte: 80 PM: 13.2/13.9File #: 01.28**WELDING INSPECTION REPORT****Resident Engineer:** Casey, William**Address:** 333 Burma Road**City:** Oakland, CA 94607**Report No:** WIR-029917**Date Inspected:** 14-Aug-2013**Project Name:** SAS Superstructure**OSM Arrival Time:** 700**Prime Contractor:** American Bridge/Fluor Enterprises, a JV**OSM Departure Time:** 1730**Contractor:** American Bridge/Fluor Enterprises, a JV**Location:** Job Site

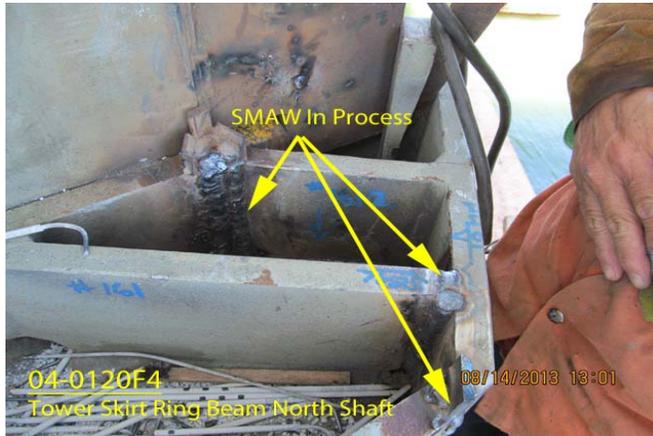
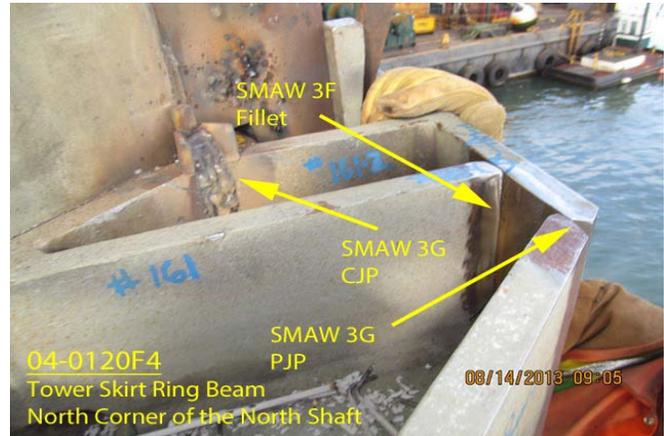
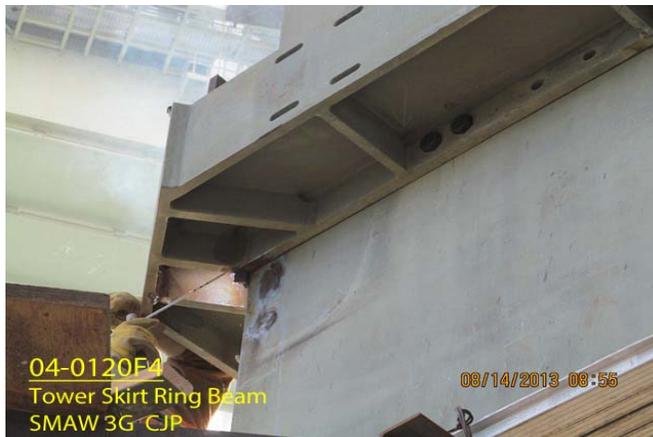
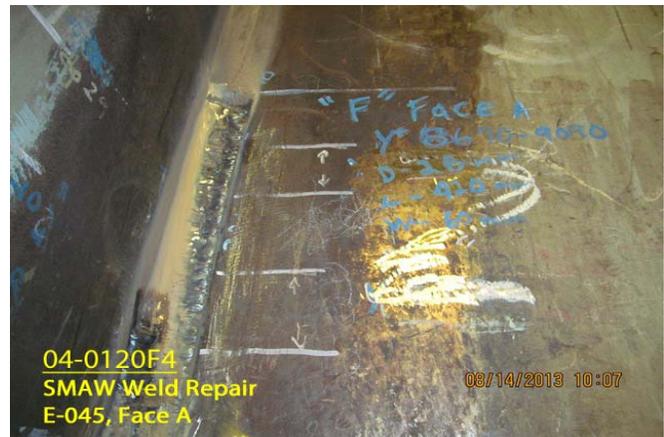
The QAI periodically observed ABF welding personnel Gao Wu Chin utilizing the Shielded Metal Arc Welding (SMAW) process in the vertical (3G) (3F), horizontal (2F) positions with Atom Arc E7018-1 HR4, 1/8" diameter electrode to weld the Complete Joint Penetration (CJP) field splice, Partial Joint Penetration (PJP) and fillet welds for the tower skirt ring beam on north CD Corner of the north shaft. At this time the QAI observed the welder was in the process of completing filler and cover passes on side A. As welding continued the QAI periodically verified welding amperage at approximately 126 amperes. Several verifications of this reading were made throughout the day with similar readings. The QAI was informed by QC Inspector Bernie Docena Welding Procedure Specification (WPS) designated for this work is identified as ABF-WPS-D1.5-1020, Rev1 and ABF-WPS-D1.5-1160 & ABF-WPS-D1.5-F1201A. QC Inspector Bernie Docena was monitoring the work for this location on this date.

The QAI periodically observed ABF welding personnel Wai Kit Lai utilizing the Shielded Metal Arc Welding (SMAW) process in the vertical (3G) position with Atom Arc E7018-1 H4R, 1/8" diameter electrode to weld excavation for a weld repair. The welding is taking place in the inner chamber between the north & east shaft at joint F, weld #E-045 on Face A side for a repair designated as 201307-004. Excavation dimensions are noted as

Y=8670mm-9090mm, Length=420mm, Width=60mm, Depth=28mm. The QAI observed the interpass temperature was maintained at approximately 375 degrees Fahrenheit with electric heating coil blankets through a heat induction system. As welding continued the QAI periodically verified welding amperage at approximately 130 amperes. Several verifications of this reading were made throughout the day with similar readings. The Welding Procedure Specification (WPS) designated for this repair was identified as ABF-WPS-D1.5-1000Repair, Rev.3. QC Inspector Bernie Docena was monitoring the progress of this repair on this date.

The welding & workmanship observed on this date appeared to be in general compliance with the contract specifications. The following pictures below detail some of the observations made on this date.
