DEPARTMENT OF TRANSPORTATION

Contract #: 04-0120F4Cty: SF/ALA Rte: 80 PM: 13.2/13.9File #: 01.28**WELDING INSPECTION REPORT****Resident Engineer:** Casey, William**Address:** 333 Burma Road**City:** Oakland, CA 94607**Report No:** WIR-029918**Date Inspected:** 15-Aug-2013**Project Name:** SAS Superstructure**OSM Arrival Time:** 700**Prime Contractor:** American Bridge/Fluor Enterprises, a JV**OSM Departure Time:** 1730**Contractor:** American Bridge/Fluor Enterprises, a JV**Location:** Job Site

Bridge No: 34-0006**Component:** See Below**Summary of Items Observed:**

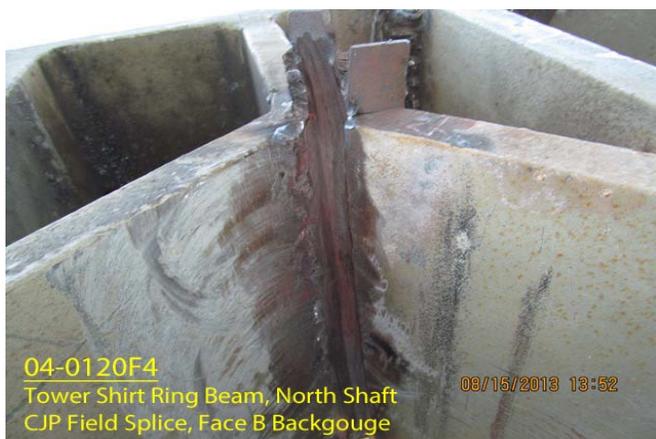
The QAI periodically observed ABF welding personnel Gao Wu Chin utilizing the Shielded Metal Arc Welding (SMAW) process in the vertical (3G) position with Atom Arc E7018-1 HR4, 1/8" diameter electrode to complete welding for the Complete Joint Penetration (CJP) field splice on the tower skirt ring beam on north CD Corner of the north shaft. At this time the QAI observed the welder was in the process of completing cover passes on side A. As welding continued the QAI verified welding amperage at approximately 138 amperes. Several verifications of this reading were made throughout the day with similar readings. The QAI verified Welding Procedure Specification (WPS) ABF-WPS-D1.5-1020, Rev1 and ABF-WPS-D1.5-1160 for compliance. Later in the shift ABF used a hoisting device to move ring beam section away from the tower to provide access for the welder to back gouge side B of the CJP weld. Welder Gao Wu Chin performed back gouging on side B. The QAI later observed QC Inspector Bernie Docena perform Magnetic Particle Testing (MT) examination on the weld groove after back gouging and prior to welding. No relevant indications were noted and SMAW welding proceeded on side B. The QAI and QC Inspector also performed visual weld inspection on fillet & Partial Joint Penetration (PJP) welds. The QC Inspector marked up several visual discrepancies for repair by welding and grinding. These areas were addressed by ABF personnel, later re-evaluated and accepted by QC Inspector Bernie Docena.
