**DEPARTMENT OF TRANSPORTATION**

Contract #: 04-0120F4Cty: SF/ALA Rte: 80 PM: 13.2/13.9File #: 1.28**WELDING INSPECTION REPORT****Resident Engineer:** Casey, William**Address:** 333 Burma Road**City:** Oakland, CA 94607**Report No:** WIR-029920**Date Inspected:** 14-Aug-2013**Project Name:** SAS Superstructure**OSM Arrival Time:** 700**Prime Contractor:** American Bridge/Fluor Enterprises, a JV**OSM Departure Time:** 1730**Contractor:** American Bridge/Fluor Enterprises, a JV**Location:** Job Site**CWI Name:** Bernie Docena, Jesse Cayabyab**CWI Present:** Yes No**Inspected CWI report:** Yes No N/A**Rod Oven in Use:** Yes No N/A**Electrode to specification:** Yes No N/A**Weld Procedures Followed:** Yes No N/A**Qualified Welders:** Yes No N/A**Verified Joint Fit-up:** Yes No N/A**Approved Drawings:** Yes No N/A**Approved WPS:** Yes No N/A**Delayed / Cancelled:** Yes No N/A**Bridge No:** 34-0006**Component:** SAS Tower**Summary of Items Observed:**

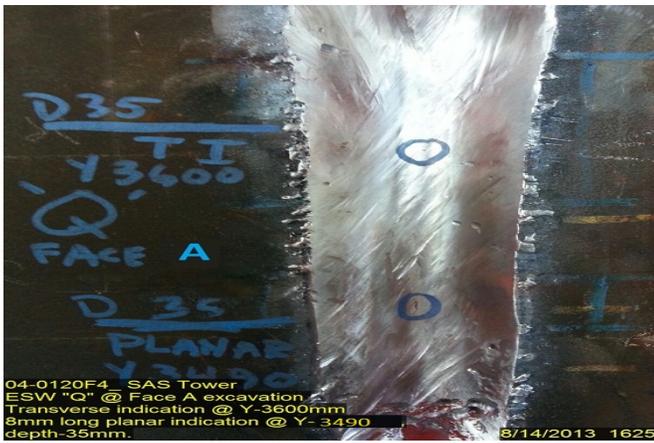
ESW E-043,"Q"-Face A:

The QA Inspector was later present to observe ABF welder Donald Plumb (WID-0891) performing excavation of ESW "QF" Face A @ Y-3390mm~3760mm to verify indications observed during Ultrasonic Testing with pulse/echo & pitch/catch method. Mr. Plumb was performing air carbon arc gouging and grinding on the excavation. ABF QC Inspector Bernie Docena was present monitoring the repair work in progress. Location of the repair is as follows:

Weld excavated at 35mm dp- Linear indication @3490, X=-4, L= 8mm, transverse indication @3600

Weld excavated at 43mm dp- two transverse indications @3600

Excavation Length Y=3390mm~3760mm, L-370mm (Excavation work in progress to be continued on the next work shift)
